# Access Compliance Report

## Public Rights-of-Way

Intersection ID: 46687	Main Street: AYERS_ORCHARD_WY	Cross Street: TROTTERS_RIDGE_RD	Location: SW
ADA ID: 025E789BD73D	Ramp Type: PerpDiag	Initial Pass/Fail: Fail	Overall Compliance: No
Severity Score: 22.5			
Codes/Mitigation Info/Possible Solution		Field Measurements/Component Compliance

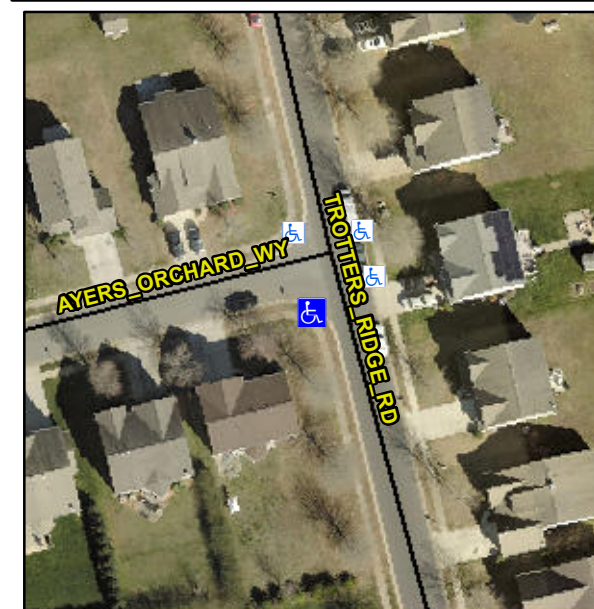
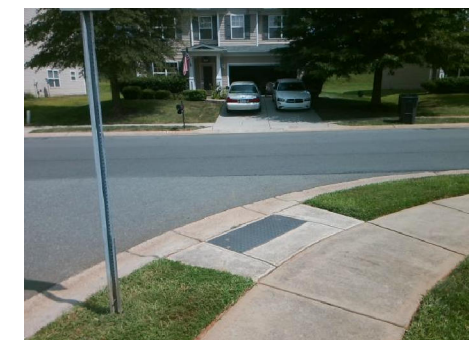
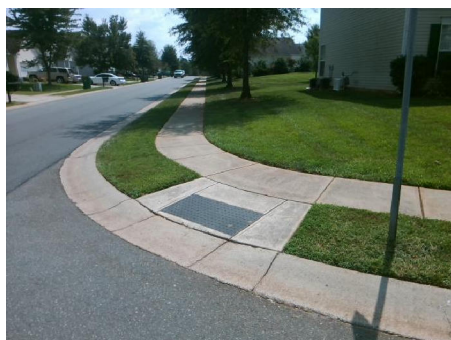
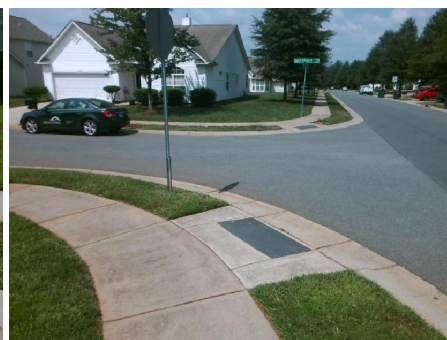
**Not Found, R304.5.1, R304.2.2, R304.5.3**

Compliance	Description	Data	Compliance	Description	Data
N/A	Ramp Length (in)	47.0	No	Ramp Slope (%)	9.3
No	Ramp Width (in)	47.5	No	Ramp XSlope (%)	2.5
N/A	Flare Type LT	N/A	N/A	Flare Type RT	N/A
N/A	Flare Slope LT (%)	N/A	N/A	Flare Slope RT (%)	N/A
N/A	Flare Traversable LT?	N/A	N/A	Flare Traversable RT?	N/A
N/A	Landing Length (in)	N/A	N/A	DWS Provided?	N/A
N/A	Landing Width (in)	N/A	N/A	DWS Contrast?	N/A
N/A	Landing Slope (%)	N/A	N/A	DWS Length (in)	N/A
N/A	Landing X Slope (%)	N/A	N/A	DWS Full Width?	N/A
N/A	Landing Curb? (Y/N)	N/A	N/A	DWS Offset (in)	N/A
N/A	Shared Landing?	N/A			
N/A	Gutter Ponding?	N/A	N/A	Gutter Slope (%)	N/A
N/A	Gutter Lip Ht (in)	N/A	N/A	Gutter X Slope (%)	N/A
N/A	Painted X Walk1?	No	N/A	Painted X Walk2?	No
	X Walk 1 Direction	To E		X Walk 2 Direction	To N
N/A	X Walk 1 Width (in)	N/A	N/A	X Walk 2 Width (in)	N/A
	X Walk 1 Slope (%)	0.9		X Walk 2 Slope (%)	0.3
	X Walk 1 X Slope (%)	0.2		X Walk 2 X Slope (%)	2.3

N/A	Ramp inside XWalk1?	N/A	N/A	Ramp inside XWalk2?	N/A
	Road Slope (%)	0.9	N/A	Clear Space?	N/A
	Road X Slope (%)	0.7	N/A	Clear Space to XWalk (in)	N/A
N/A	Any Obstructions?	N/A	N/A	Storm Grate/Utility Hazard?	N/A
	Obstruction Type			Storm Grate/Utility Type	
		N/A			N/A
			Yes	Surface Condition? (G/P)	Good

**Remove & Replace Curb Ramp With Two New Directional Ramps or Equivalent.**
