# Access Compliance Report

## Public Rights-of-Way

### (Curb Ramps)

Intersection ID: 18764	Main Street: RAMA_RD	Cross Street: SPRINGHOUSE_LN	Location: E
ADA ID: 0268BD5C4EF5	Ramp Type: PerpDiag	Initial Pass/Fail: Fail	Overall Compliance: No
		Severity Score: 25

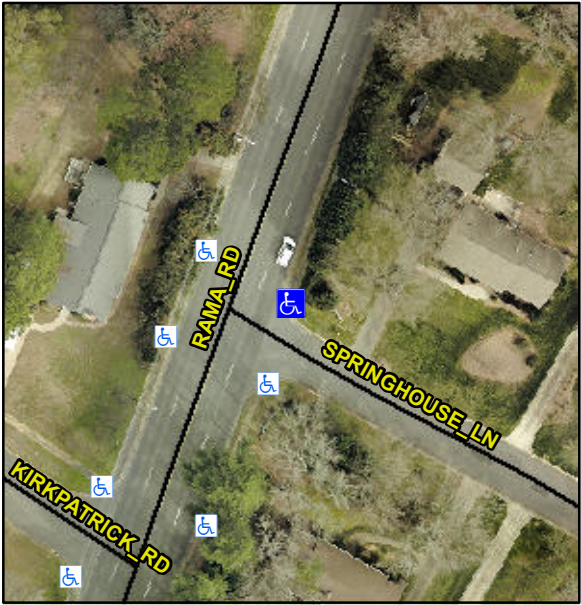
Possible Solutions:		<b>Compliance</b>	<b>Description</b>	<b>Data</b>
	<b>Remove &amp; Replace Curb Ramp With Two New Directional Ramps or Equivalent.</b>		<b>No</b>	Ramp Length (in)	<b>60.0</b>
			<b>Yes</b>	Ramp Width (in)	<b>48.0</b>
			<b>N/A</b>	Flare Type LT	<b>N/A</b>
			<b>N/A</b>	Flare Slope LT (%)	<b>N/A</b>
			<b>N/A</b>	Flare Traversable LT?	<b>N/A</b>
			<b>N/A</b>	Landing Length (in)	<b>N/A</b>
			<b>N/A</b>	Landing Width (in)	<b>N/A</b>
			<b>N/A</b>	Landing Slope (%)	<b>N/A</b>
			<b>N/A</b>	Landing X Slope (%)	<b>N/A</b>
<p>Surveyor Notes:</p> <p><b>N/A</b></p>			<b>N/A</b>	Landing Curb? (Y/N)	<b>N/A</b>
			<b>N/A</b>	Shared Landing?	<b>N/A</b>
			<b>N/A</b>	Gutter Ponding?	<b>N/A</b>
			<b>N/A</b>	Gutter Lip Ht (in)	<b>N/A</b>
			<b>N/A</b>	Painted X Walk1?	<b>No</b>
				X Walk 1 Direction	<b>To NW</b>

<b>N/A</b>	X Walk 1 Width (in)	<b>N/A</b>
				X Walk 1 Slope (%)	<b>3.9</b>
				X Walk 1 X Slope (%)	<b>0.3</b>
			<b>N/A</b>	Ramp inside XWalk1?	<b>N/A</b>
<p>PROW/ADA:</p> <p><b>Not Found, R304.2.2, R304.5.3</b></p>			<b>N/A</b>	Road Slope (%)	<b>3.0</b>
				Road X Slope (%)	<b>3.4</b>
			<b>N/A</b>	Any Obstructions?	<b>N/A</b>
				Obstruction Type	
			<b>N/A</b>		<b>N/A</b>
			<b>Yes</b>	Surface Condition? (G/P)	<b>Good</b>
Total Cost:		\$ 3200.00
