# Access Compliance Report

## Public Rights-of-Way

### (Curb Ramps)

Intersection ID: 11311	Main Street: MILTON_RD	Cross Street: N_SHARON_AMITY_RD	Location: NW
ADA ID: 02719705AC76	Ramp Type: PerpDiag	Initial Pass/Fail: Fail	Overall Compliance: No
			Severity Score: 21.25

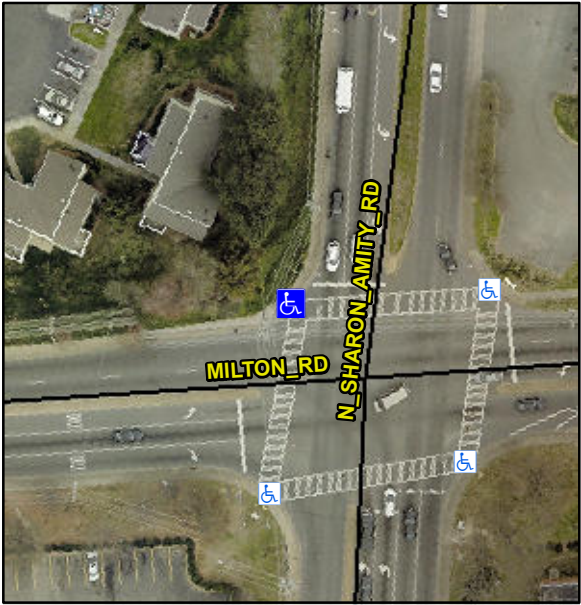
Possible Solutions:		<b>Compliance</b>	<b>Description</b>	<b>Data</b>
	<b>Remove &amp; Replace Curb Ramp With Two New Directional Ramps or Equivalent. Restripe Crosswalk.</b>		<b>No</b>	Ramp Length (in)	59.5
			<b>No</b>	Ramp Width (in)	36.0
			<b>N/A</b>	Flare Type LT	N/A
			<b>N/A</b>	Flare Slope LT (%)	N/A
			<b>N/A</b>	Flare Traversable LT?	N/A
			<b>N/A</b>	Landing Length (in)	N/A
			<b>N/A</b>	Landing Width (in)	N/A
			<b>N/A</b>	Landing Slope (%)	N/A
			<b>N/A</b>	Landing X Slope (%)	N/A
<p>Surveyor Notes:</p> <p><b>N/A</b></p> <p>PROW/ADA:</p> <p><b>R304.5.1, R304.2.2</b></p>			<b>N/A</b>	Flare Type RT	N/A
			<b>N/A</b>	Flare Slope RT (%)	N/A
			<b>N/A</b>	Flare Traversable RT?	N/A
			<b>N/A</b>	DWS Provided?	N/A
			<b>N/A</b>	DWS Contrast?	N/A
			<b>N/A</b>	DWS Length (in)	N/A
			<b>N/A</b>	DWS Full Width?	N/A

<b>N/A</b>	DWS Offset (in)	N/A
			<b>N/A</b>	Shared Landing?	N/A
			<b>N/A</b>	Gutter Ponding?	N/A
			<b>N/A</b>	Gutter Lip Ht (in)	N/A
			<b>N/A</b>	Painted X Walk1?	Yes
				X Walk 1 Direction	To S
			<b>N/A</b>	X Walk 1 Width (in)	101.0
				X Walk 1 Slope (%)	0.4
				X Walk 1 X Slope (%)	1.2
			<b>N/A</b>	Ramp inside XWalk1?	Yes
				Road Slope (%)	1.2
				Road X Slope (%)	0.4
			<b>N/A</b>	Any Obstructions?	N/A
				Obstruction Type	
Total Cost:		\$ 3400.00			
			<b>N/A</b>		<b>N/A</b>
			<b>Yes</b>	Surface Condition? (G/P)	<b>Good</b>
