# Access Compliance Report

## Public Rights-of-Way

### (Curb Ramps)

Intersection ID: 8573	Main Street: N_GRAHAM_ST	Cross Street: ATANDO_AV	Location:	W
ADA ID: 0271C665D69E	Ramp Type: Perp	Initial Pass/Fail: Fail	Overall Compliance: No	Severity Score: 12.5

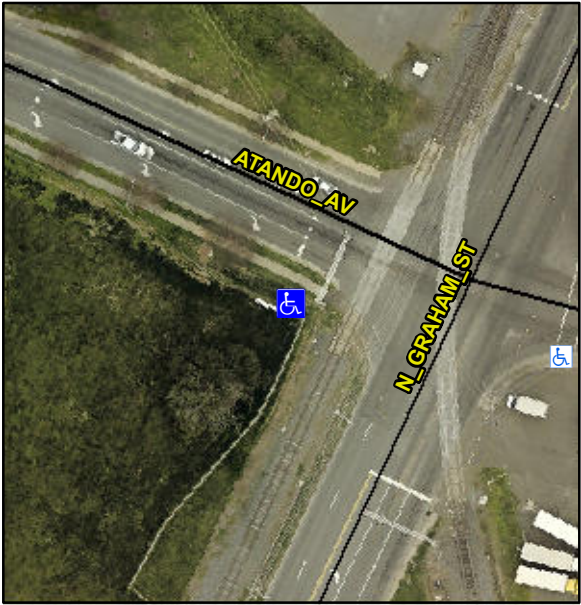
Possible Solutions:		<b>Compliance</b>	<b>Description</b>	<b>Data</b>
	Remove & Replace Entire Ramp.		N/A	Ramp Length (in)	126.0
			Yes	Ramp Width (in)	59.5
			N/A	Flare Type LT	N/A
			N/A	Flare Slope LT (%)	N/A
			N/A	Flare Traversable LT?	N/A
			N/A	Landing Length (in)	N/A
			N/A	Landing Width (in)	N/A
			N/A	Landing Slope (%)	N/A
			N/A	Landing X Slope (%)	N/A
<p>Surveyor Notes:</p> <p>N/A</p> <p>PROW/ADA:</p> <p>R304.2.2</p>			N/A	Flare Type RT	N/A
			N/A	Flare Slope RT (%)	N/A
			N/A	Flare Traversable RT?	N/A
			N/A	DWS Provided?	N/A
			N/A	DWS Contrast?	N/A
			N/A	DWS Length (in)	N/A
			N/A	DWS Full Width?	N/A
			N/A	DWS Offset (in)	N/A
			N/A	Shared Landing?	N/A
			N/A	Gutter Ponding?	N/A
			N/A	Gutter Lip Ht (in)	1.0
			N/A	Painted X Walk1?	No
				X Walk 1 Direction	To NE
			N/A	X Walk 1 Width (in)	N/A
				X Walk 1 Slope (%)	0.4

X Walk 1 X Slope (%)	2.5
			N/A	Ramp inside XWalk1?	N/A
			N/A	Road Slope (%)	N/A
			N/A	Road X Slope (%)	N/A
			N/A	Any Obstructions?	N/A
Total Cost:		\$ 1850.00		Obstruction Type	
			N/A		N/A
			Yes	Surface Condition? (G/P)	Good
