Access Compliance Report

Public Rights-of-Way

(Curb Ramps)

| Intersection ID: N/A | Main Street: HOOVER_CREEK_BV | Cross Street: STEELECROFT_PY | Location: NW |

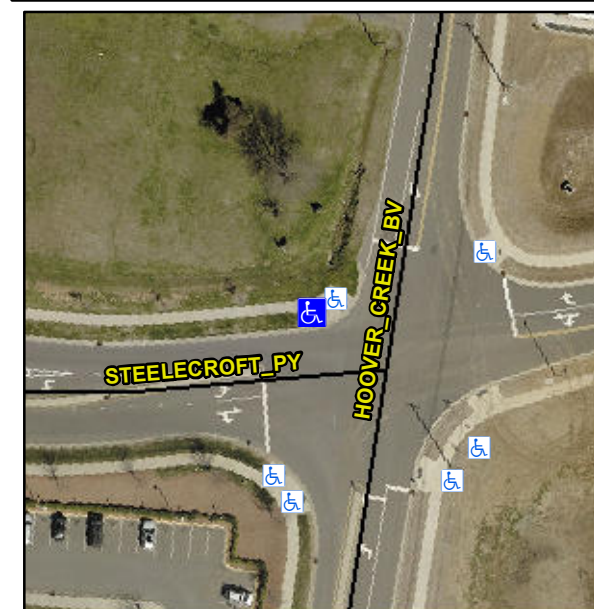
| ADA ID: 027DF06B8DDF | Ramp Type: Perp | Initial Pass/Fail: Fail | Overall Compliance: No |

R304.2.2, R304.5.3

| Compliance | Description | Data | Compliance | Description | Data |
|---|---|---|---|---|---|
| N/A | Ramp Length (in) | 96.0 | No | Ramp Slope (%) | 9.3 |
| Yes | Ramp Width (in) | 48.0 | No | Ramp XSlope (%) | 2.5 |

Possible Solutions:

Remove & Replace Entire Ramp.
