## Access Compliance Report Public Rights-of-Way (Curb Ramps)

Intersection ID: 16133 Main Street: E\_W\_T\_HARRIS\_BV Cross Street: IDLEWILD\_RD\_NORTH Location: NW

ADA ID: 02AF7DEDB17A Ramp Type: Perp Initial Pass/Fail: Fail Overall Compliance: No Severity Score: 47.5

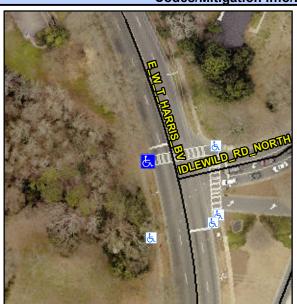
Not Found, R304.5.1, R304.2.2

Field Measurements/Component Compliance					
Comp	liance Description	Data	Comp	liance Description	Data
N/A	Ramp Length (in)	54.0	No	Ramp Slope (%)	11.5
No	Ramp Width (in)	30.0	Yes	Ramp XSlope (%)	0.5
N/A	Flare Type LT	N/A	N/A	Flare Type RT	N/A
N/A	Flare Slope LT (%)	N/A	N/A	Flare Slope RT (%)	N/A
N/A	Flare Traversable LT?	N/A	N/A	Flare Traversable RT?	N/A
N/A	Landing Length (in)	N/A	N/A	DWS Provided?	N/A
N/A	Landing Width (in)	N/A	N/A	DWS Contrast?	N/A
N/A	Landing Slope (%)	N/A	N/A	DWS Length (in)	N/A
N/A	Landing X Slope (%)	N/A	N/A	DWS Full Width?	N/A
N/A	Landing Curb? (Y/N)	N/A	N/A	DWS Offset (in)	N/A
N/A	Shared Landing?	N/A			
N/A	Gutter Ponding?	N/A	N/A	Gutter Slope (%)	N/A
N/A	Gutter Lip Ht (in)	N/A	N/A	Gutter X Slope (%)	N/A
N/A	Painted X Walk1?	Yes	N/A	Painted X Walk2?	N/A
	X Walk 1 Direction	To E		X Walk 2 Direction	N/A
N/A	X Walk 1 Width (in)	108.0	N/A	X Walk 2 Width (in)	N/A
	X Walk 1 Slope (%)	2.8		X Walk 2 Slope (%)	N/A

X Walk 1 X Slope (%)	1.6		X Walk 2 X Slope (%)	N/A
N/A	Ramp inside XWalk1?	Yes	N/A	Ramp inside XWalk2?	N/A
	Road Slope (%)	N/A	N/A	Clear Space?	N/A
	Road X Slope (%)	N/A	N/A	Clear Space to XWalk (in)	N/A
N/A	Any Obstructions?	N/A	N/A	Storm Grate/Utility Hazard?	N/A
	Obstruction Type			Storm Grate/Utility Type	
		N/A			N/A
			Yes	Surface Condition? (G/P)	Good
April 1

Remove & Replace Entire Ramp.
