Access Compliance Report

Public Rights-of-Way

(Curb Ramps)

Intersection ID: 22417	Main Street: BRACKENBURY_LN	Cross Street: N_BRACKENBURY_LN	Location:	N
ADA ID: 02C3D6820899	Ramp Type: PerpDiag	Initial Pass/Fail: Fail	Overall Compliance: No	Severity Score: 8.75

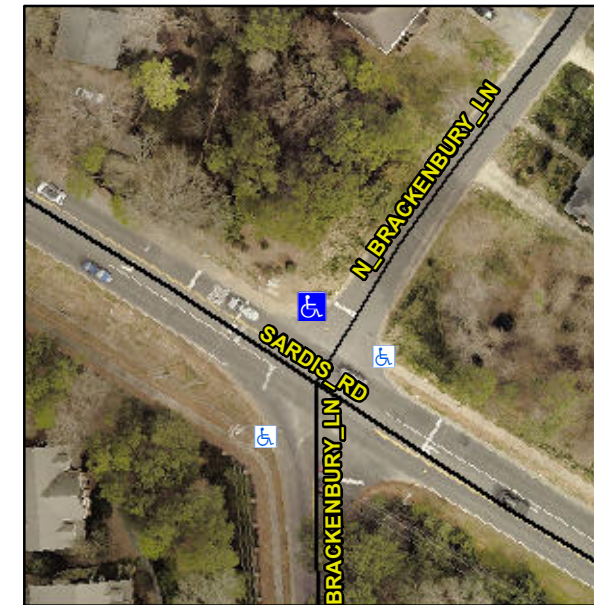
Not Found, R304.5.1

Compliance	Description	Data	Compliance	Description	Data
N/A	Ramp Length (in)	60.0	Yes	Ramp Slope (%)	5.4
No	Ramp Width (in)	40.5	Yes	Ramp XSlope (%)	0.7
N/A	Flare Type LT	N/A	N/A	Flare Type RT	N/A
N/A	Flare Slope LT (%)	N/A	N/A	Flare Slope RT (%)	N/A
N/A	Flare Traversable LT?	N/A	N/A	Flare Traversable RT?	N/A
N/A	Landing Length (in)	N/A	N/A	DWS Provided?	N/A
N/A	Landing Width (in)	N/A	N/A	DWS Contrast?	N/A
N/A	Landing Slope (%)	N/A	N/A	DWS Length (in)	N/A
N/A	Landing X Slope (%)	N/A	N/A	DWS Full Width?	N/A
N/A	Landing Curb? (Y/N)	N/A	N/A	DWS Offset (in)	N/A
N/A	Shared Landing?	N/A			
N/A	Gutter Ponding?	N/A	N/A	Gutter Slope (%)	N/A
N/A	Gutter Lip Ht (in)	N/A	N/A	Gutter X Slope (%)	N/A
N/A	Painted X Walk1?	No	N/A	Painted X Walk2?	No
	X Walk 1 Direction	To SW		X Walk 2 Direction	To SE
N/A	X Walk 1 Width (in)	N/A	N/A	X Walk 2 Width (in)	N/A
	X Walk 1 Slope (%)	1.1		X Walk 2 Slope (%)	2.6
	X Walk 1 X Slope (%)	2.8		X Walk 2 X Slope (%)	3.2

N/A	Ramp inside XWalk1?	N/A	N/A	Ramp inside XWalk2?	N/A
	Road Slope (%)	0.1	N/A	Clear Space?	N/A
	Road X Slope (%)	6.3	N/A	Clear Space to XWalk (in)	N/A
N/A	Any Obstructions?	N/A	N/A	Storm Grate/Utility Hazard?	N/A
	Obstruction Type			Storm Grate/Utility Type	
		N/A			N/A
			Yes	Surface Condition? (G/P)	Good

Remove & Replace Curb Ramp With Two New Directional Ramps or Equivalent.
