# Access Compliance Report

## Public Rights-of-Way

### (Curb Ramps)

Intersection ID: 11844	Main Street: E_W_T_HARRIS_BV	Cross Street: TANTILLA_CR	Location: SW
ADA ID: 02CB795619FD	Ramp Type: PerpDiag	Initial Pass/Fail: Fail	Overall Compliance: No
Severity Score: 25			
Codes/Mitigation Info/Possible Solution		Field Measurements/Component Compliance

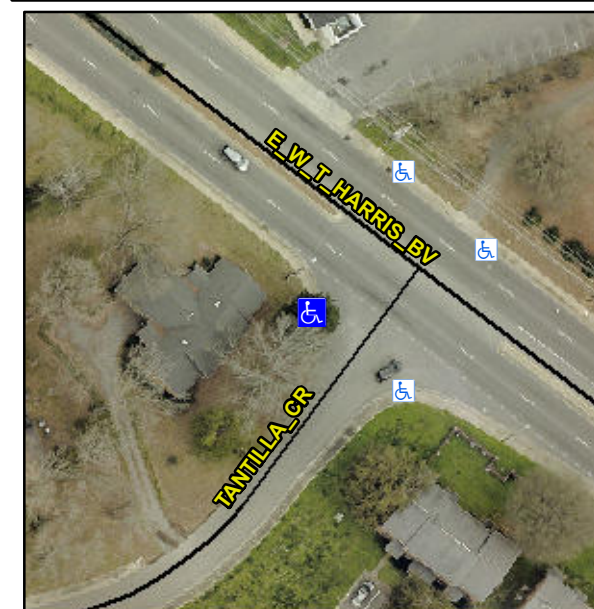
Compliance	Description	Data	Compliance	Description	Data
N/A	Ramp Length (in)	59.5	No	Ramp Slope (%)	12.4
Yes	Ramp Width (in)	48.0	Yes	Ramp XSlope (%)	1.6
N/A	Flare Type LT	N/A	N/A	Flare Type RT	N/A
N/A	Flare Slope LT (%)	N/A	N/A	Flare Slope RT (%)	N/A
N/A	Flare Traversable LT?	N/A	N/A	Flare Traversable RT?	N/A
N/A	Landing Length (in)	N/A	N/A	DWS Provided?	N/A
N/A	Landing Width (in)	N/A	N/A	DWS Contrast?	N/A
N/A	Landing Slope (%)	N/A	N/A	DWS Length (in)	N/A
N/A	Landing X Slope (%)	N/A	N/A	DWS Full Width?	N/A
N/A	Landing Curb? (Y/N)	N/A	N/A	DWS Offset (in)	N/A
N/A	Shared Landing?	N/A			
N/A	Gutter Ponding?	N/A	N/A	Gutter Slope (%)	N/A
N/A	Gutter Lip Ht (in)	N/A	N/A	Gutter X Slope (%)	N/A
N/A	Painted X Walk1?	No	N/A	Painted X Walk2?	No
	X Walk 1 Direction	To SE		X Walk 2 Direction	To NE
N/A	X Walk 1 Width (in)	N/A	N/A	X Walk 2 Width (in)	N/A
	X Walk 1 Slope (%)	0.2		X Walk 2 Slope (%)	4.0
	X Walk 1 X Slope (%)	2.3		X Walk 2 X Slope (%)	0.7

N/A	Ramp inside XWalk1?	N/A	N/A	Ramp inside XWalk2?	N/A
	Road Slope (%)	2.0	N/A	Clear Space?	N/A
	Road X Slope (%)	4.1	N/A	Clear Space to XWalk (in)	N/A
N/A	Any Obstructions?	N/A	N/A	Storm Grate/Utility Hazard?	N/A
	Obstruction Type			Storm Grate/Utility Type	
		N/A			N/A
			Yes	Surface Condition? (G/P)	Good

**Remove & Replace Curb Ramp With Two New Directional Ramps or Equivalent.**

**R304.2.2**
