# Access Compliance Report

## Public Rights-of-Way

### (Curb Ramps)

Intersection ID: 30383	Main Street: BELLSOUTH_DR	Cross Street: CENTRAL_AV	Location: E
ADA ID: 02CFED2649B4	Ramp Type: Perp	Initial Pass/Fail: Fail	Overall Compliance: No
Severity Score: 12.5			
Codes/Mitigation Info/Possible Solution		Field Measurements/Component Compliance

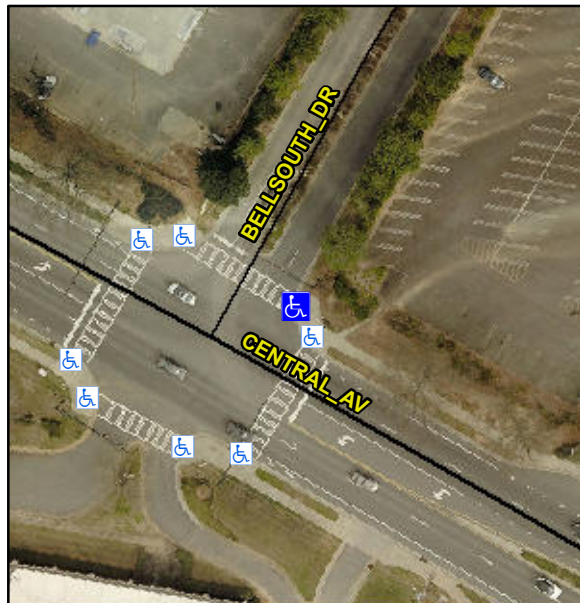
**Not Found, R304.5.3**

Compliance	Description	Data	Compliance	Description	Data
N/A	Ramp Length (in)	60.0	Yes	Ramp Slope (%)	6.4
Yes	Ramp Width (in)	48.0	No	Ramp XSlope (%)	5.2
N/A	Flare Type LT	N/A	N/A	Flare Type RT	N/A
N/A	Flare Slope LT (%)	N/A	N/A	Flare Slope RT (%)	N/A
N/A	Flare Traversable LT?	N/A	N/A	Flare Traversable RT?	N/A
N/A	Landing Length (in)	N/A	N/A	DWS Provided?	N/A
N/A	Landing Width (in)	N/A	N/A	DWS Contrast?	N/A
N/A	Landing Slope (%)	N/A	N/A	DWS Length (in)	N/A
N/A	Landing X Slope (%)	N/A	N/A	DWS Full Width?	N/A
N/A	Landing Curb? (Y/N)	N/A	N/A	DWS Offset (in)	N/A
N/A	Shared Landing?	N/A			
N/A	Gutter Ponding?	N/A	N/A	Gutter Slope (%)	N/A
N/A	Gutter Lip Ht (in)	N/A	N/A	Gutter X Slope (%)	N/A
N/A	Painted X Walk1?	Yes	N/A	Painted X Walk2?	N/A
	X Walk 1 Direction	To NW		X Walk 2 Direction	N/A
N/A	X Walk 1 Width (in)	112.0	N/A	X Walk 2 Width (in)	N/A
	X Walk 1 Slope (%)	4.0		X Walk 2 Slope (%)	N/A
	X Walk 1 X Slope (%)	7.2		X Walk 2 X Slope (%)	N/A

N/A	Ramp inside XWalk1?	Yes	N/A	Ramp inside XWalk2?	N/A
	Road Slope (%)	N/A	N/A	Clear Space?	N/A
	Road X Slope (%)	N/A	N/A	Clear Space to XWalk (in)	N/A
N/A	Any Obstructions?	N/A	N/A	Storm Grate/Utility Hazard?	N/A
	Obstruction Type			Storm Grate/Utility Type	
		N/A			N/A
		Yes		Surface Condition? (G/P)	Good

**Remove & Replace Entire Ramp.**
