## Access Compliance Report Public Rights-of-Way (Curb Ramps)

Intersection ID: 15201	Main Str	eet: ALBEMARLE_RD	Cross	Street:	LAWYERS_RD	Location:	S		
ADA ID: 02D7E95ECC08	Ramp Type: IslandPerp			Initial Pass/Fail: Fail Overall Compliance:					
· · · ·			initial						13.75
Codes/Mitigation Info/Possible Solution				Field Measurements/Component Compliance   Compliance Description Data

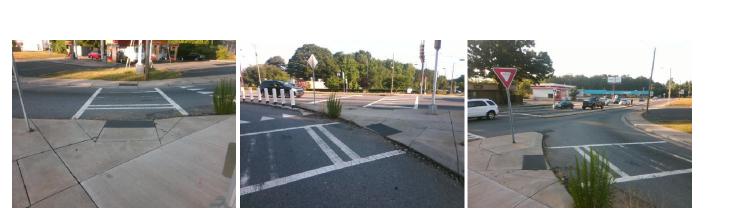
20.01	Possible Solutions:		Compliance Description			Data Compliance Description		
	als/	Remove & Replace Entire Ram	р.	N/A	Ramp Length (in)	60.0	No	Ramp Slope (%)	9.0
				Yes	Ramp Width (in)	48.0	No	Ramp XSlope (%)	3.6
				N/A	Flare Type LT	N/A	N/A	Flare Type RT	N/A
A ALE	E A			N/A	Flare Slope LT (%)	N/A	N/A	Flare Slope RT (%)	N/A
TEELLAN	1/2			N/A	Flare Traversable LT?	N/A	N/A	Flare Traversable RT?	N/A
Cut I	ANG STON			N/A	Landing Length (in)	N/A	N/A	DWS Provided?	N/A
	Balla	Surveyor Notes:		N/A	Landing Width (in)	N/A	N/A	DWS Contrast?	N/A

L. C. C.		N/A		N/A	Landing Slope (%)	N/A	N/A	DWS Length (in)	N/A
5	Per Constant			N/A	Landing X Slope (%)	N/A	N/A	DWS Full Width?	N/A
				N/A	Landing Curb? (Y/N)	N/A	N/A	DWS Offset (in)	N/A
11 1	1 Ast			N/A	Shared Landing?	N/A			
1 13 / MA	A Prot	PROW/ADA:		N/A	Gutter Ponding?	N/A	N/A	Gutter Slope (%)	N/A
A A A A A A A A A A A A A A A A A A A	10	R304.2.2, R304.5.3		N/A	Gutter Lip Ht (in)	N/A	N/A	Gutter X Slope (%)	N/A
	1981			N/A	Painted X Walk1?	Yes	N/A	Painted X Walk2?	N/A
	the little				X Walk 1 Direction	To S		X Walk 2 Direction	N/A
				N/A	X Walk 1 Width (in)	120.0	N/A	X Walk 2 Width (in)	N/A
Street 1 Name	ALBEMARLE RD				X Walk 1 Slope (%)	2.6		X Walk 2 Slope (%)	N/A
Stop Condition-Street 2	YieldSign				X Walk 1 X Slope (%)	4.0		X Walk 2 X Slope (%)	N/A
Street 2 Name	N/A			N/A	Ramp inside XWalk1?	Yes	N/A	Ramp inside XWalk2?	N/A
Stop Condition-Street 1	N/A				Road Slope (%)	N/A	N/A	Clear Space?	N/A
