Access Compliance Report

Public Rights-of-Way

(Curb Ramps)

| Intersection ID: 15351 | Main Street: CLANTON_RD | Cross Street: BARRINGER_DR | Location: NE |

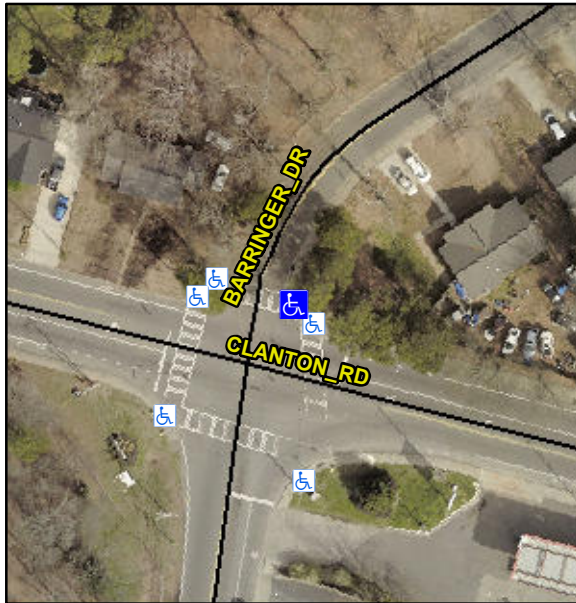
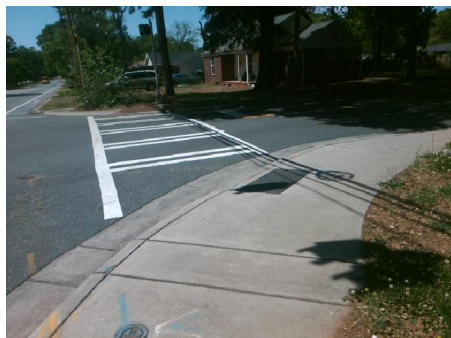
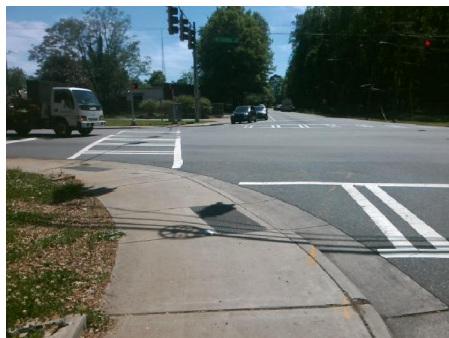
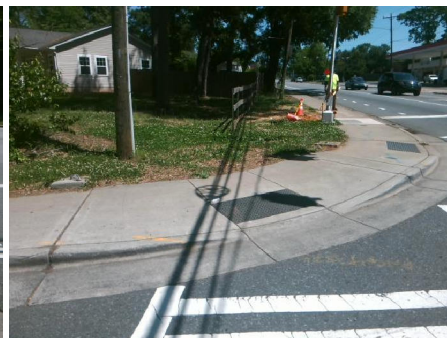
| ADA ID: 02DA96E8F605 | Ramp Type: Perp | Initial Pass/Fail: Pass | Overall Compliance: No |

Not Found, R304.2.1, R305.2

| Compliance | Description | Data | Compliance | Description | Data |
|---|---|---|---|---|---|
| No | Landing Length (in) | 28.0 | Yes | DWS Provided? | Yes |
| N/A | Landing Curb? (Y/N) | No | No | DWS Offset (in) | 6.0 |

Remove & Replace Entire Ramp.

Total Cost: \$ 1850.00
