Access Compliance Report

Public Rights-of-Way

(Curb Ramps)

Intersection ID: 24472	Main Street: CARMEL_RD	Cross Street: QUAIL_VIEW_RD	Location: NE
ADA ID: 02EB5D03AAC9	Ramp Type: PerpDiag	Initial Pass/Fail: Fail	Overall Compliance: No
Severity Score: 22.5			
Codes/Mitigation Info/Possible Solution		Field Measurements/Component Compliance

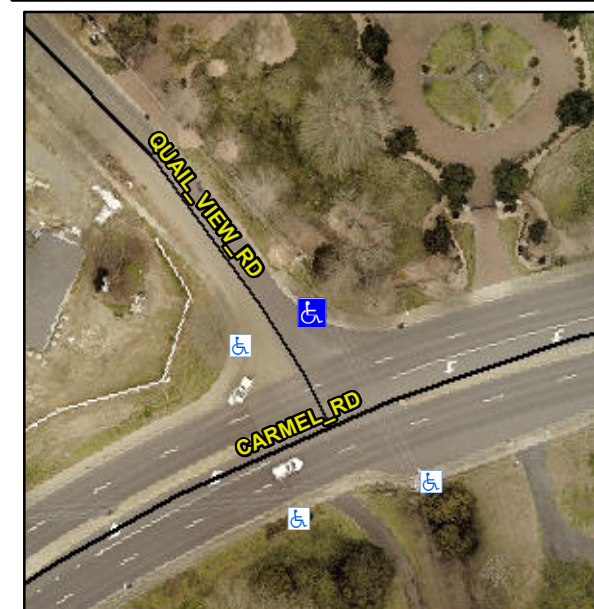
Not Found, R304.5.1, R304.2.2, R304.5.3

Compliance	Description	Data	Compliance	Description	Data
N/A	Ramp Length (in)	59.0	No	Ramp Slope (%)	10.2
No	Ramp Width (in)	47.0	No	Ramp XSlope (%)	2.5
N/A	Flare Type LT	N/A	N/A	Flare Type RT	N/A
N/A	Flare Slope LT (%)	N/A	N/A	Flare Slope RT (%)	N/A
N/A	Flare Traversable LT?	N/A	N/A	Flare Traversable RT?	N/A
N/A	Landing Length (in)	N/A	N/A	DWS Provided?	N/A
N/A	Landing Width (in)	N/A	N/A	DWS Contrast?	N/A
N/A	Landing Slope (%)	N/A	N/A	DWS Length (in)	N/A
N/A	Landing X Slope (%)	N/A	N/A	DWS Full Width?	N/A
N/A	Landing Curb? (Y/N)	N/A	N/A	DWS Offset (in)	N/A
N/A	Shared Landing?	N/A			
N/A	Gutter Ponding?	N/A	N/A	Gutter Slope (%)	N/A
N/A	Gutter Lip Ht (in)	N/A	N/A	Gutter X Slope (%)	N/A
N/A	Painted X Walk1?	No	N/A	Painted X Walk2?	No
	X Walk 1 Direction	To SW		X Walk 2 Direction	To SE
N/A	X Walk 1 Width (in)	N/A	N/A	X Walk 2 Width (in)	N/A
	X Walk 1 Slope (%)	2.1		X Walk 2 Slope (%)	1.9
	X Walk 1 X Slope (%)	1.5		X Walk 2 X Slope (%)	1.0

N/A	Ramp inside XWalk1?	N/A	N/A	Ramp inside XWalk2?	N/A
	Road Slope (%)	1.3	N/A	Clear Space?	N/A
	Road X Slope (%)	3.4	N/A	Clear Space to XWalk (in)	N/A
N/A	Any Obstructions?	N/A	N/A	Storm Grate/Utility Hazard?	N/A
	Obstruction Type			Storm Grate/Utility Type	
		N/A			N/A
			Yes	Surface Condition? (G/P)	Good

Remove & Replace Curb Ramp With Two New Directional Ramps or Equivalent.
