# Access Compliance Report

## Public Rights-of-Way

### (Curb Ramps)

Intersection ID: 11796	Main Street: N_PINE_ST	Cross Street: W_6TH_ST	Location: S
ADA ID: 02EB6E49ECEC	Ramp Type: Perp	Initial Pass/Fail: Fail	Overall Compliance: No
Severity Score: 13.75			
Codes/Mitigation Info/Possible Solution		Field Measurements/Component Compliance

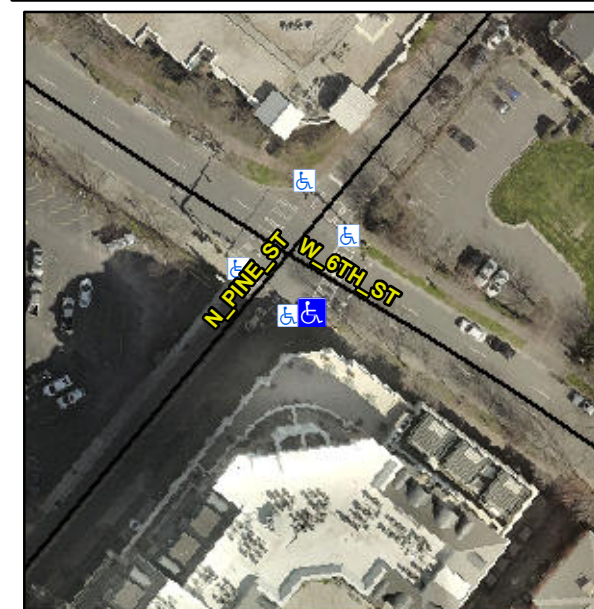
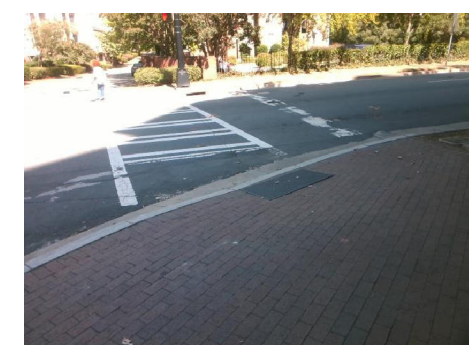
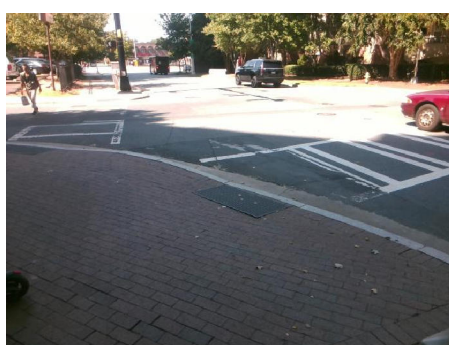
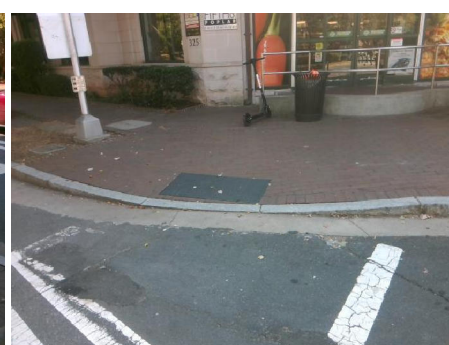
**Not Found, R304.2.2**

Compliance	Description	Data	Compliance	Description	Data
N/A	Ramp Length (in)	60.0	No	Ramp Slope (%)	9.7
Yes	Ramp Width (in)	51.0	Yes	Ramp XSlope (%)	2.2
N/A	Flare Type LT	N/A	N/A	Flare Type RT	N/A
N/A	Flare Slope LT (%)	N/A	N/A	Flare Slope RT (%)	N/A
N/A	Flare Traversable LT?	N/A	N/A	Flare Traversable RT?	N/A
N/A	Landing Length (in)	N/A	N/A	DWS Provided?	N/A
N/A	Landing Width (in)	N/A	N/A	DWS Contrast?	N/A
N/A	Landing Slope (%)	N/A	N/A	DWS Length (in)	N/A
N/A	Landing X Slope (%)	N/A	N/A	DWS Full Width?	N/A
N/A	Landing Curb? (Y/N)	N/A	N/A	DWS Offset (in)	N/A
N/A	Shared Landing?	N/A			
N/A	Gutter Ponding?	N/A	N/A	Gutter Slope (%)	N/A
N/A	Gutter Lip Ht (in)	N/A	N/A	Gutter X Slope (%)	N/A
N/A	Painted X Walk1?	Yes	N/A	Painted X Walk2?	N/A
	X Walk 1 Direction	To NE		X Walk 2 Direction	N/A
N/A	X Walk 1 Width (in)	99.0	N/A	X Walk 2 Width (in)	N/A
	X Walk 1 Slope (%)	0.2		X Walk 2 Slope (%)	N/A
	X Walk 1 X Slope (%)	4.9		X Walk 2 X Slope (%)	N/A

N/A	Ramp inside XWalk1?	Yes	N/A	Ramp inside XWalk2?	N/A
	Road Slope (%)	N/A	N/A	Clear Space?	N/A
	Road X Slope (%)	N/A	N/A	Clear Space to XWalk (in)	N/A
N/A	Any Obstructions?	N/A	N/A	Storm Grate/Utility Hazard?	N/A
	Obstruction Type			Storm Grate/Utility Type	
		N/A			N/A
			Yes	Surface Condition? (G/P)	Good

**Remove & Replace Entire Ramp.**

Total Cost: \$ 1850.00
