Access Compliance Report

Public Rights-of-Way

(Curb Ramps)

Intersection ID: 11480	Main Street: N_CEDAR_ST	Cross Street: W_5TH_ST	Location:	S
ADA ID: 02FB7603E7C8	Ramp Type: PerpDiag	Initial Pass/Fail: Fail	Overall Compliance: No	Severity Score: 25
Codes/Mitigation Info/Possible Solution		Field Measurements/Component Compliance

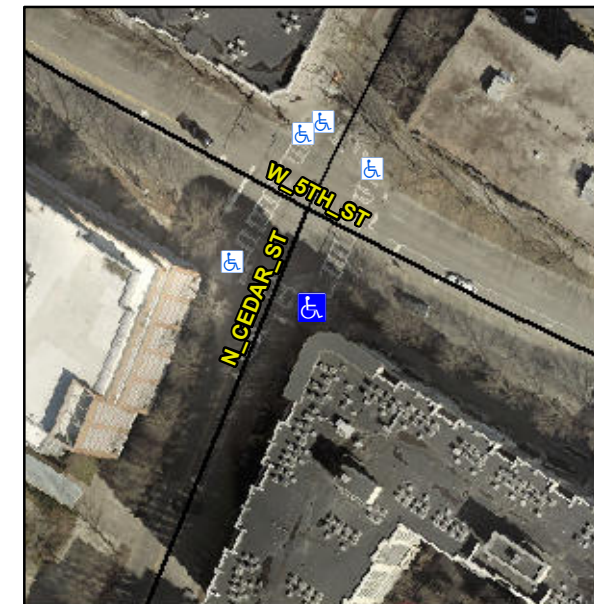
Not Found, R304.5.3

Compliance	Description	Data	Compliance	Description	Data
N/A	Ramp Length (in)	140.0	Yes	Ramp Slope (%)	7.5
Yes	Ramp Width (in)	86.0	No	Ramp XSlope (%)	7.0
N/A	Flare Type LT	N/A	N/A	Flare Type RT	N/A
N/A	Flare Slope LT (%)	N/A	N/A	Flare Slope RT (%)	N/A
N/A	Flare Traversable LT?	N/A	N/A	Flare Traversable RT?	N/A
N/A	Landing Length (in)	N/A	N/A	DWS Provided?	N/A
N/A	Landing Width (in)	N/A	N/A	DWS Contrast?	N/A
N/A	Landing Slope (%)	N/A	N/A	DWS Length (in)	N/A
N/A	Landing X Slope (%)	N/A	N/A	DWS Full Width?	N/A
N/A	Landing Curb? (Y/N)	N/A	N/A	DWS Offset (in)	N/A
N/A	Shared Landing?	N/A			
N/A	Gutter Ponding?	N/A	N/A	Gutter Slope (%)	N/A
N/A	Gutter Lip Ht (in)	N/A	N/A	Gutter X Slope (%)	N/A
N/A	Painted X Walk1?	Yes	N/A	Painted X Walk2?	Yes
	X Walk 1 Direction	To NE		X Walk 2 Direction	To NW
N/A	X Walk 1 Width (in)	105.0	N/A	X Walk 2 Width (in)	107.0
	X Walk 1 Slope (%)	2.5		X Walk 2 Slope (%)	4.3
	X Walk 1 X Slope (%)	2.6		X Walk 2 X Slope (%)	3.0

N/A	Ramp inside XWalk1?	Yes	N/A	Ramp inside XWalk2?	Yes
	Road Slope (%)	6.4	N/A	Clear Space?	N/A
	Road X Slope (%)	4.3	N/A	Clear Space to XWalk (in)	N/A
N/A	Any Obstructions?	N/A	N/A	Storm Grate/Utility Hazard?	N/A
	Obstruction Type			Storm Grate/Utility Type	
		N/A			N/A
		Yes		Surface Condition? (G/P)	Good

Remove & Replace Curb Ramp With Two New Directional Ramps or Equivalent.

Total Cost: \$ 3200.00
