Access Compliance Report Public Rights-of-Way (Curb Ramps)

Main Street: KENNEDY ST Intersection ID: 8498 **Cross Street: N GRAHAM ST** Location: SE Initial Pass/Fail: Fail **Overall Compliance: No** 10 ADA ID: 02FF5D7236A4 Ramp Type: Combination2 **Severity Score:**

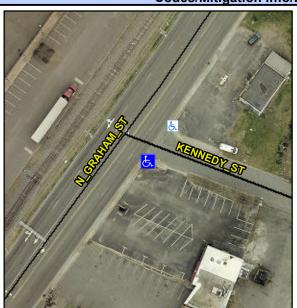
Street 1 Name StopSign **KENNEDY ST** Stop Condition-Street 1 N/A Street 2 Name Stop Condition-Street 2 N/A Possible Solutions: Compliance Description Remove & Replace Entire Ramp. N/A N/A N/A N/A N/A No Surveyor Notes: N/A LT RP < 5% N/A N/A N/A N/A PROW/ADA: N/A N/A Not Found, R304.5.1, R304.5.3 N/ N/ N/ N/ N/
