# Access Compliance Report

## Public Rights-of-Way

### (Curb Ramps)

Intersection ID: 10772	Main Street: E_36TH_ST	Cross Street: THE_PLAZA	Location: N
ADA ID: 030E7B0F69D5	Ramp Type: PerpDiag	Initial Pass/Fail: Fail	Overall Compliance: No
Severity Score: 8.75			
Codes/Mitigation Info/Possible Solution		Field Measurements/Component Compliance

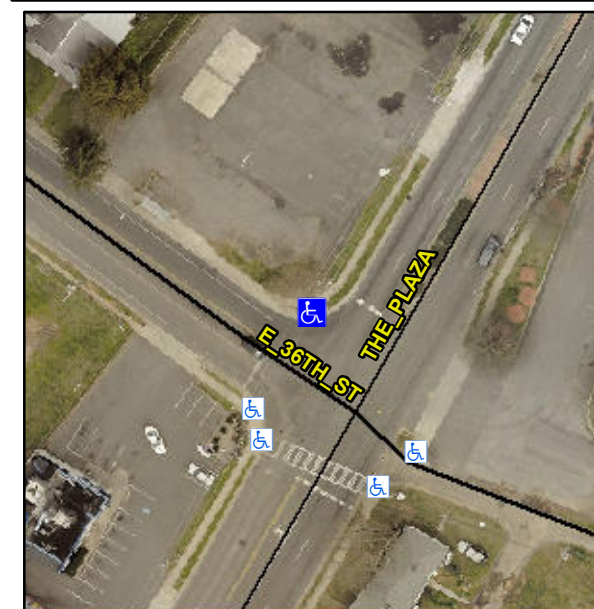
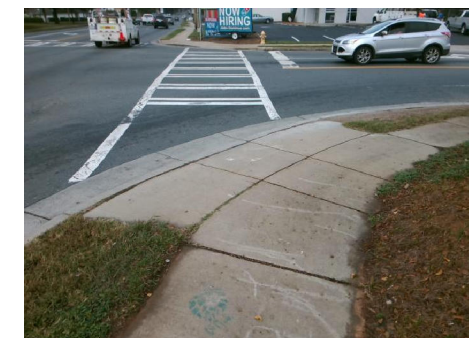
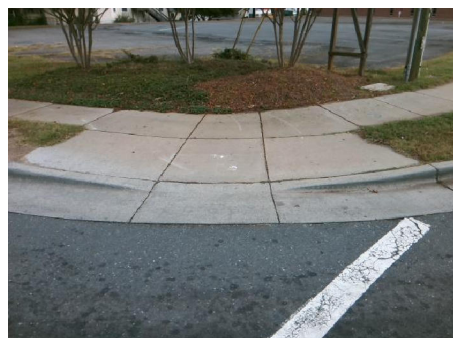
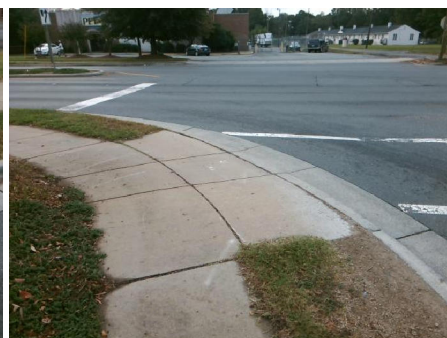
Compliance	Description	Data	Compliance	Description	Data
N/A	Ramp Length (in)	47.0	Yes	Ramp Slope (%)	8.1
No	Ramp Width (in)	41.5	Yes	Ramp XSlope (%)	1.7
N/A	Flare Type LT	N/A	N/A	Flare Type RT	N/A
N/A	Flare Slope LT (%)	N/A	N/A	Flare Slope RT (%)	N/A
N/A	Flare Traversable LT?	N/A	N/A	Flare Traversable RT?	N/A
N/A	Landing Length (in)	N/A	N/A	DWS Provided?	N/A
N/A	Landing Width (in)	N/A	N/A	DWS Contrast?	N/A
N/A	Landing Slope (%)	N/A	N/A	DWS Length (in)	N/A
N/A	Landing X Slope (%)	N/A	N/A	DWS Full Width?	N/A
N/A	Landing Curb? (Y/N)	N/A	N/A	DWS Offset (in)	N/A
N/A	Shared Landing?	N/A			
N/A	Gutter Ponding?	N/A	N/A	Gutter Slope (%)	N/A
N/A	Gutter Lip Ht (in)	0.5	N/A	Gutter X Slope (%)	N/A
N/A	Painted X Walk1?	Yes	N/A	Painted X Walk2?	No
	X Walk 1 Direction	To SW		X Walk 2 Direction	To SE
N/A	X Walk 1 Width (in)	107.0	N/A	X Walk 2 Width (in)	N/A
	X Walk 1 Slope (%)	0.0		X Walk 2 Slope (%)	4.1
	X Walk 1 X Slope (%)	1.1		X Walk 2 X Slope (%)	1.2

N/A	Ramp inside XWalk1?	Yes	N/A	Ramp inside XWalk2?	N/A
	Road Slope (%)	0.6	N/A	Clear Space?	N/A
	Road X Slope (%)	0.2	N/A	Clear Space to XWalk (in)	N/A
N/A	Any Obstructions?	N/A	N/A	Storm Grate/Utility Hazard?	N/A
	Obstruction Type			Storm Grate/Utility Type	
		N/A			N/A
		Yes		Surface Condition? (G/P)	Good

Possible Solutions:

**Remove & Replace Curb Ramp With Two New Directional Ramps or Equivalent.**

**Not Found, R304.5.1**

Total Cost: \$ 3200.00
