Access Compliance Report

Public Rights-of-Way

(Curb Ramps)

| Intersection ID: 10021686 | Main Street: BRAY_DR | Cross Street: N/A | Location: W |

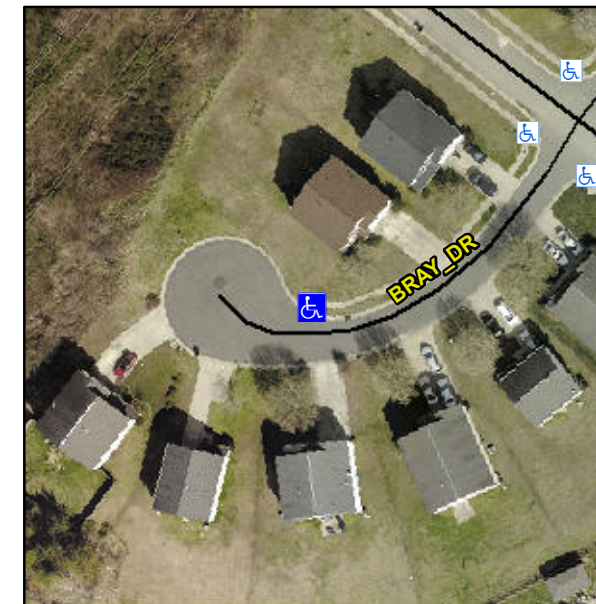
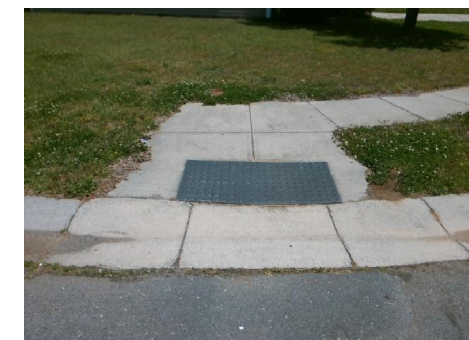
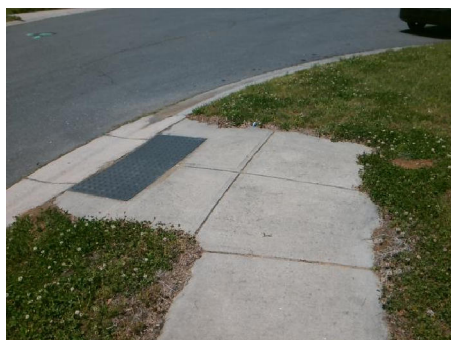
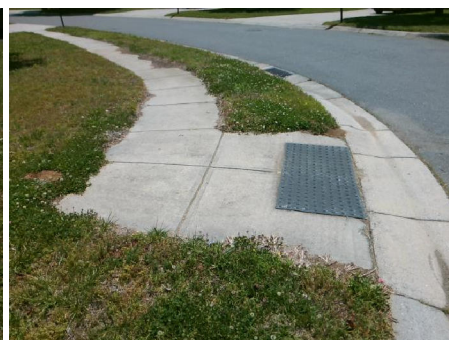
| ADA ID: 0322BDAE0A12 | Ramp Type: Perp | Initial Pass/Fail: Fail | Overall Compliance: No |

Not Found, R304.2.2, R304.5.3

| Compliance | Description | Data | Compliance | Description | Data |
|---|---|---|---|---|---|
| N/A | Ramp Length (in) | 50.0 | No | Ramp Slope (%) | 8.4 |
| Yes | Ramp Width (in) | 48.0 | No | Ramp XSlope (%) | 2.5 |

Remove & Replace Entire Ramp.
