Access Compliance Report

Public Rights-of-Way

(Curb Ramps)

Intersection ID: 15195	Main Street: ALBEMARLE_RD	Cross Street: FARM_POND_LN	Location: SE
ADA ID: 0335BC3BE9A3	Ramp Type: Perp	Initial Pass/Fail: Fail	Overall Compliance: No
Severity Score: 21.25			
Codes/Mitigation Info/Possible Solution		Field Measurements/Component Compliance

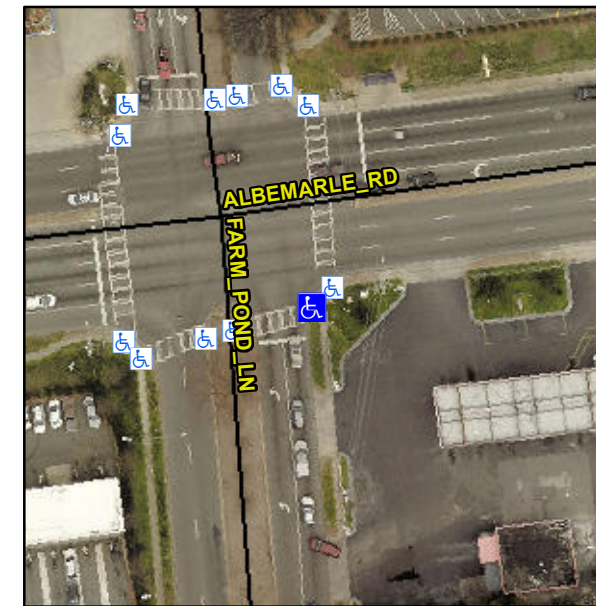
Not Found, R304.5.1, R304.5.3

Compliance	Description	Data	Compliance	Description	Data
N/A	Ramp Length (in)	65.0	Yes	Ramp Slope (%)	7.3
No	Ramp Width (in)	45.0	No	Ramp XSlope (%)	5.4
N/A	Flare Type LT	N/A	N/A	Flare Type RT	N/A
N/A	Flare Slope LT (%)	N/A	N/A	Flare Slope RT (%)	N/A
N/A	Flare Traversable LT?	N/A	N/A	Flare Traversable RT?	N/A
N/A	Landing Length (in)	N/A	N/A	DWS Provided?	N/A
N/A	Landing Width (in)	N/A	N/A	DWS Contrast?	N/A
N/A	Landing Slope (%)	N/A	N/A	DWS Length (in)	N/A
N/A	Landing X Slope (%)	N/A	N/A	DWS Full Width?	N/A
N/A	Landing Curb? (Y/N)	N/A	N/A	DWS Offset (in)	N/A
N/A	Shared Landing?	N/A			
N/A	Gutter Ponding?	N/A	N/A	Gutter Slope (%)	N/A
N/A	Gutter Lip Ht (in)	N/A	N/A	Gutter X Slope (%)	N/A
N/A	Painted X Walk1?	Yes	N/A	Painted X Walk2?	N/A
	X Walk 1 Direction	To W		X Walk 2 Direction	N/A
N/A	X Walk 1 Width (in)	110.0	N/A	X Walk 2 Width (in)	N/A
	X Walk 1 Slope (%)	2.3		X Walk 2 Slope (%)	N/A
	X Walk 1 X Slope (%)	5.8		X Walk 2 X Slope (%)	N/A

N/A	Ramp inside XWalk1?	Yes	N/A	Ramp inside XWalk2?	N/A
	Road Slope (%)	N/A	N/A	Clear Space?	N/A
	Road X Slope (%)	N/A	N/A	Clear Space to XWalk (in)	N/A
N/A	Any Obstructions?	N/A	N/A	Storm Grate/Utility Hazard?	N/A
	Obstruction Type			Storm Grate/Utility Type	
		N/A			N/A
			Yes	Surface Condition? (G/P)	Good

Possible Solutions:

Remove & Replace Entire Ramp.
