Access Compliance Report Public Rights-of-Way (Curb Ramps)

Main Street: MALLARD CREEK RD **Cross Street: SUMMERCROFT LN** Location: Intersection ID: 4562 NW ADA ID: 03530F2A7B44 Ramp Type: MedianPerp Initial Pass/Fail: Fail **Overall Compliance: No** Severity Score: 21.25

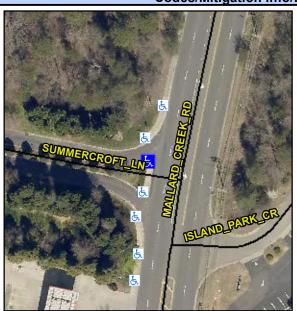
SUMMERCROFT LN Street 1 Name Stop Condition-Street 2 None Street 2 Name N/A Stop Condition-Street 1 N/A Possible Solutions: Remove & Replace Entire Ramp. Surveyor Notes: N/A PROW/ADA: R304.5.1, R304.2.2

Comp	liance Description	Data	Comp	liance	Description	Data
N/A	Ramp Length (in)	42.0	No	Ramp	Slope (%)	10.2
No	Ramp Width (in)	42.0	Yes	Ramp	XSlope (%)	0.5
N/A	Flare Type LT	N/A	N/A	Flare	Type RT	N/A
N/A	Flare Slope LT (%)	N/A	N/A	Flare	Slope RT (%)	N/A
N/A	Flare Traversable LT?	N/A	N/A	Flare	Traversable RT?	N/A
N/A	Landing Length (in)	N/A	N/A	DWS	Provided?	N/A
N/A	Landing Width (in)	N/A	N/A	DWS	Contrast?	N/A
N/A	Landing Slope (%)	N/A	N/A	DWS	Length (in)	N/A
N/A	Landing X Slope (%)	N/A	N/A	DWS	Full Width?	N/A
N/A	Landing Curb? (Y/N)	N/A	N/A	DWS	Offset (in)	N/A
N/A	Shared Landing?	N/A				
N/A	Gutter Ponding?	N/A	N/A	Gutte	r Slope (%)	N/A
N/A	Gutter Lip Ht (in)	N/A	N/A	Gutte	r X Slope (%)	N/A
N/A	Painted X Walk1?	No	N/A	Painte	ed X Walk2?	N/A
	X Walk 1 Direction	To N		X Wa	k 2 Direction	N/A
N/A	X Walk 1 Width (in)	N/A	N/A	X Wa	k 2 Width (in)	N/A
	X Walk 1 Slope (%)	5.1		X Wa	k 2 Slope (%)	N/A
	X Walk 1 X Slope (%)	0.2		X Wa	k 2 X Slope (%)	N/A
