Access Compliance Report

Public Rights-of-Way

(Curb Ramps)

Intersection ID: 45629	Main Street: SARDIS_RD_NORTH	Cross Street: GALLERIA_BV	Location: SE
ADA ID: 036127C6E104	Ramp Type: PerpDiag	Initial Pass/Fail: Fail	Overall Compliance: No
Codes/Mitigation Info/Possible Solution		Field Measurements/Component Compliance	
Severity Score: 30

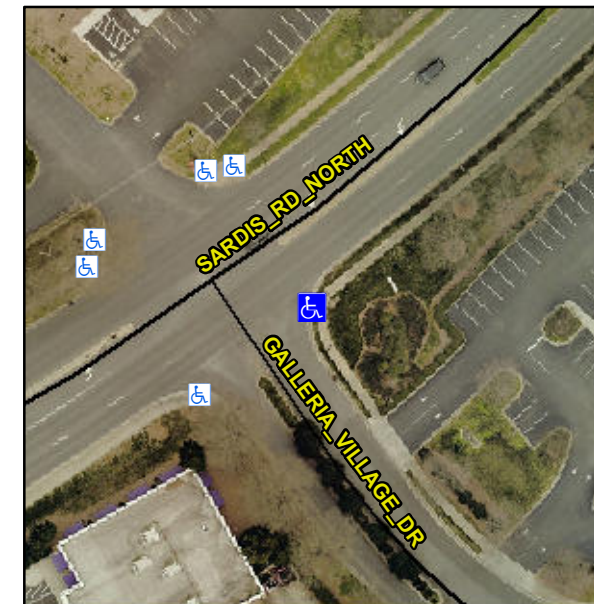
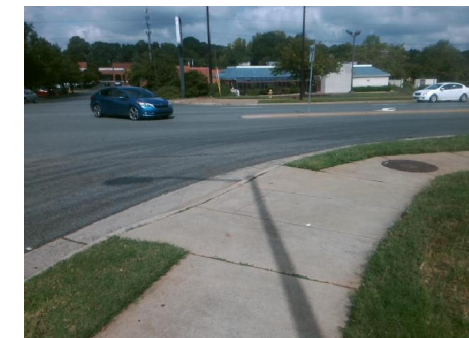
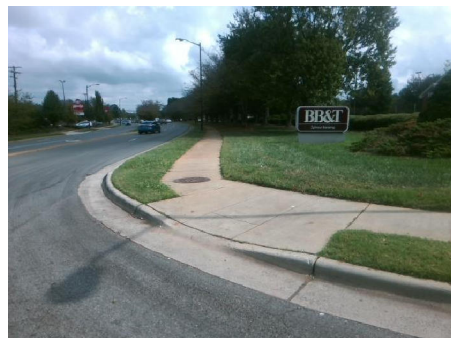
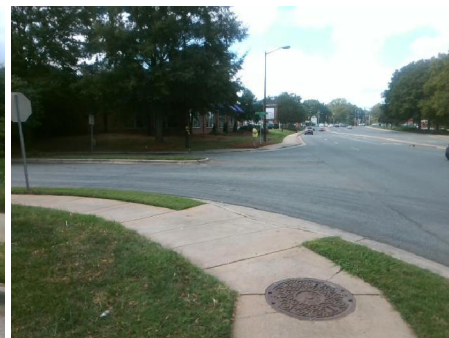
Not Found, R304.5.1, R304.5.3

Compliance	Description	Data	Compliance	Description	Data
N/A	Ramp Length (in)	96.0	Yes	Ramp Slope (%)	6.9
No	Ramp Width (in)	35.0	No	Ramp XSlope (%)	6.1
N/A	Flare Type LT	N/A	N/A	Flare Type RT	N/A
N/A	Flare Slope LT (%)	N/A	N/A	Flare Slope RT (%)	N/A
N/A	Flare Traversable LT?	N/A	N/A	Flare Traversable RT?	N/A
N/A	Landing Length (in)	N/A	N/A	DWS Provided?	N/A
N/A	Landing Width (in)	N/A	N/A	DWS Contrast?	N/A
N/A	Landing Slope (%)	N/A	N/A	DWS Length (in)	N/A
N/A	Landing X Slope (%)	N/A	N/A	DWS Full Width?	N/A
N/A	Landing Curb? (Y/N)	N/A	N/A	DWS Offset (in)	N/A
N/A	Shared Landing?	N/A			
N/A	Gutter Ponding?	N/A	N/A	Gutter Slope (%)	N/A
N/A	Gutter Lip Ht (in)	N/A	N/A	Gutter X Slope (%)	N/A
N/A	Painted X Walk1?	No	N/A	Painted X Walk2?	No
	X Walk 1 Direction	To N		X Walk 2 Direction	To SW
N/A	X Walk 1 Width (in)	N/A	N/A	X Walk 2 Width (in)	N/A
	X Walk 1 Slope (%)	0.8		X Walk 2 Slope (%)	1.2
	X Walk 1 X Slope (%)	0.7		X Walk 2 X Slope (%)	1.0

N/A	Ramp inside XWalk1?	N/A	N/A	Ramp inside XWalk2?	N/A
	Road Slope (%)	1.1	N/A	Clear Space?	N/A
	Road X Slope (%)	1.3	N/A	Clear Space to XWalk (in)	N/A
N/A	Any Obstructions?	N/A	N/A	Storm Grate/Utility Hazard?	N/A
	Obstruction Type			Storm Grate/Utility Type	
		N/A			N/A
			Yes	Surface Condition? (G/P)	Good

Remove & Replace Curb Ramp With Two New Directional Ramps or Equivalent.
