# Access Compliance Report

## Public Rights-of-Way

| Intersection ID: N/A | Main Street: GLENBURN_LN | Cross Street: GLENLIVET_CT | Location: NW |
| ADA ID: 03616428BEAF | Ramp Type: PerpDiag | Initial Pass/Fail: Fail | Overall Compliance: No |

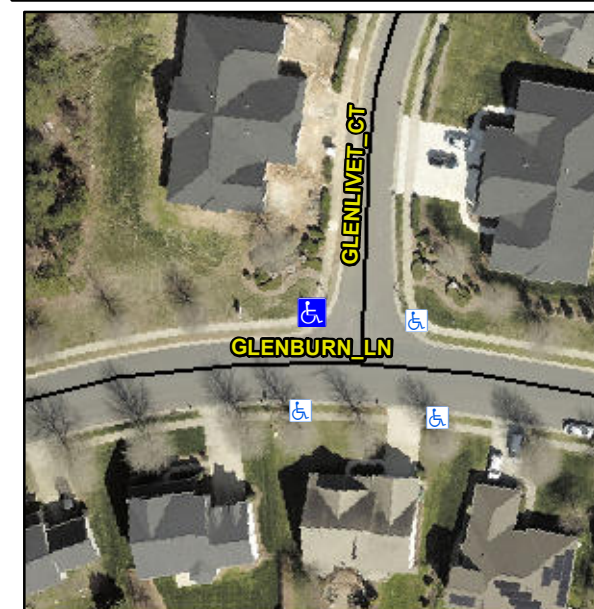
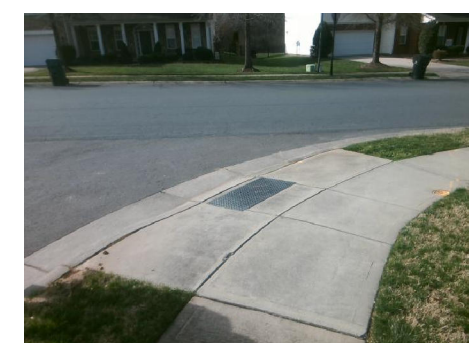
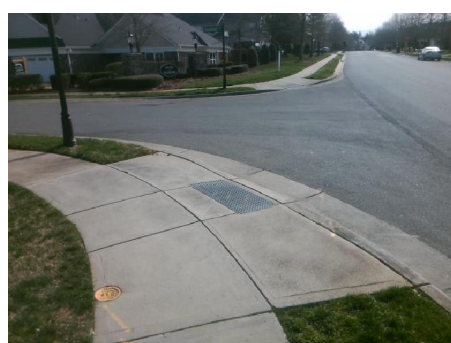
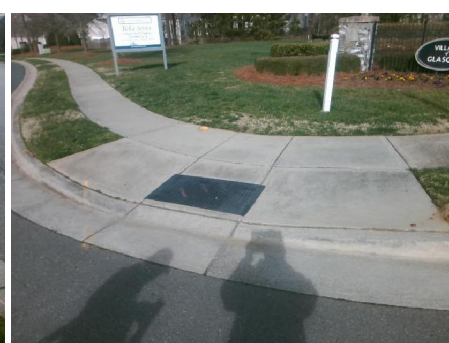
**Not Found, R304.5.1, R304.2.2, R304.5.3**

| Compliance | Description | Data | Compliance | Description | Data |
|---|---|---|---|---|---|
| N/A | Ramp Length (in) | 46.0 | No | Ramp Slope (%) | 9.9 |
| No | Ramp Width (in) | 41.0 | No | Ramp XSlope (%) | 3.4 |

**Remove & Replace Curb Ramp With Two New Directional Ramps or Equivalent.**
