# Access Compliance Report

## Public Rights-of-Way

### (Curb Ramps)

Intersection ID: 49803	Main Street: ATKINS_RIDGE_DR	Cross Street: MATARESE_CT	Location: S
ADA ID: 0371D9F8167D	Ramp Type: PerpDiag	Initial Pass/Fail: Fail	Overall Compliance: No
Codes/Mitigation Info/Possible Solution		Field Measurements/Component Compliance

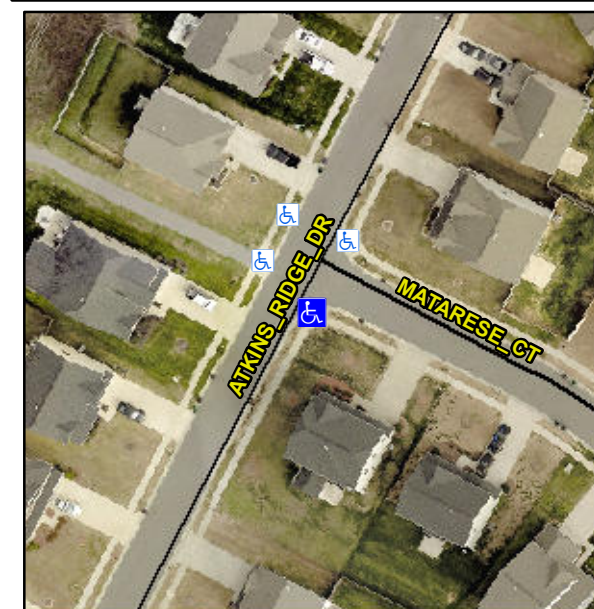
**N/A**

**Not Found, R304.5.1, R304.5.3**

Compliance	Description	Data	Compliance	Description	Data
N/A	Ramp Length (in)	49.0	Yes	Ramp Slope (%)	6.2
No	Ramp Width (in)	47.0	No	Ramp XSlope (%)	7.3
N/A	Flare Type LT	N/A	N/A	Flare Type RT	N/A
N/A	Flare Slope LT (%)	N/A	N/A	Flare Slope RT (%)	N/A
N/A	Flare Traversable LT?	N/A	N/A	Flare Traversable RT?	N/A
N/A	Landing Length (in)	N/A	N/A	DWS Provided?	N/A
N/A	Landing Width (in)	N/A	N/A	DWS Contrast?	N/A
N/A	Landing Slope (%)	N/A	N/A	DWS Length (in)	N/A
N/A	Landing X Slope (%)	N/A	N/A	DWS Full Width?	N/A
N/A	Landing Curb? (Y/N)	N/A	N/A	DWS Offset (in)	N/A
N/A	Shared Landing?	N/A			
N/A	Gutter Ponding?	N/A	N/A	Gutter Slope (%)	N/A
N/A	Gutter Lip Ht (in)	N/A	N/A	Gutter X Slope (%)	N/A
N/A	Painted X Walk1?	No	N/A	Painted X Walk2?	No
	X Walk 1 Direction	To NE		X Walk 2 Direction	To NW
N/A	X Walk 1 Width (in)	N/A	N/A	X Walk 2 Width (in)	N/A
	X Walk 1 Slope (%)	7.1		X Walk 2 Slope (%)	0.5
	X Walk 1 X Slope (%)	3.9		X Walk 2 X Slope (%)	6.8

N/A	Ramp inside XWalk1?	N/A	N/A	Ramp inside XWalk2?	N/A
	Road Slope (%)	5.6	N/A	Clear Space?	N/A
	Road X Slope (%)	4.4	N/A	Clear Space to XWalk (in)	N/A
N/A	Any Obstructions?	N/A	N/A	Storm Grate/Utility Hazard?	N/A
	Obstruction Type			Storm Grate/Utility Type	
		N/A			N/A
		Yes		Surface Condition? (G/P)	Good

**Remove & Replace Curb Ramp With Two New Directional Ramps or Equivalent.**

Total Cost: \$ 3200.00
