Surface Condition? (G/P)

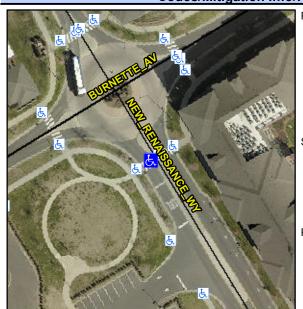
Intersection ID: 52583 Main Street: NEW_RENAISSANCE_WY Cross Street: N/A Location: SE

Total Cost: \$ 1650.00

NEW RENAISSANCE WY
Stop Condition-Street 2
None
Street 2 Name
N/A
Stop Condition-Street 1
N/A

Surveyor Notes:
N/A
