## Access Compliance Report Public Rights-of-Way (Curb Ramps)

Intersection ID: 53631	Main St	eet: PROVIDENCE_RD_WEST	Cross	Street <sup>.</sup>	BEACON_VALLEY_S	т		Location:	NE
ADA ID: 0383D6F1E15C Ramp Type: PerpDiag			Initial	nitial Pass/Fail: Fail Overall Compliance: No				o Severity Score:	10
Codes/Mitigation Info/Possible Solution				Field Measurements/Component Compliance					
	The second secon	Possible Solutions:		Compliance Description		Data	Data Compliance Description		Data
		Remove & Replace Curb Ramp	With	N/A	Ramp Length (in)	96.0	Yes	Ramp Slope (%)	5.4
		Two New Directional Ramps or Equivalent.		No	Ramp Width (in)	43.0	No	Ramp XSlope (%)	3.5
				N/A	Flare Type LT	N/A	N/A	Flare Type RT	N/A
				N/A	Flare Slope LT (%)	N/A	N/A	Flare Slope RT (%)	N/A
				N/A	Flare Traversable LT?	N/A	N/A	Flare Traversable RT?	N/A
				N/A	Landing Length (in)	N/A	N/A	DWS Provided?	N/A
CA DEC		Surveyor Notes:		N/A	Landing Width (in)	N/A	N/A	DWS Contrast?	N/A
ADD A		N/A		N/A	Landing Slope (%)	N/A	N/A	DWS Length (in)	N/A

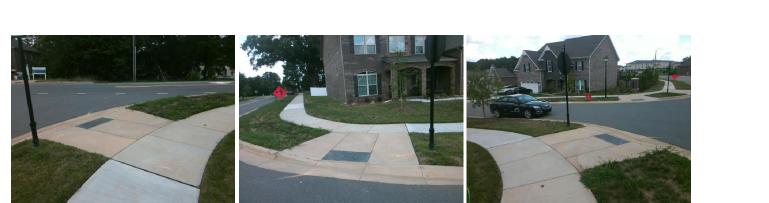
A COLOR	L B B L	le.		N/A	Landing X Slope (%)	N/A	N/A	DWS Full Width?	N/A
E E				N/A	Landing Curb? (Y/N)	N/A	N/A	DWS Offset (in)	N/A
10 10 10 10 LON	TOP			N/A	Shared Landing?	N/A			
6 DEEDERS TR. V	6.	PROW/ADA:		N/A	Gutter Ponding?	N/A	N/A	Gutter Slope (%)	N/A
a starting	R304.5.1, R304.5.3		N/A	Gutter Lip Ht (in)	N/A	N/A	Gutter X Slope (%)	N/A	
Contra and a state of	1 4 36	,		N/A	Painted X Walk1?	No	N/A	Painted X Walk2?	No
A THE AND A CONTRACT OF					X Walk 1 Direction	To SW		X Walk 2 Direction	To SE
			N/A	X Walk 1 Width (in)	N/A	N/A	X Walk 2 Width (in)	N/A	
Street 1 Name	PROVIDENCE RD WEST				X Walk 1 Slope (%)	3.9		X Walk 2 Slope (%)	1.9
Stop Condition-Street 2	None				X Walk 1 X Slope (%)	0.5		X Walk 2 X Slope (%)	4.6
Street 2 Name	BEACON VALLEY ST			N/A	Ramp inside XWalk1?	N/A	N/A	Ramp inside XWalk2?	N/A
Stop Condition-Street 1	StopSign				Road Slope (%)	4.9	N/A	Clear Space?	N/A
					Road X Slope (%)	0.7	N/A	Clear Space to XWalk (in)	N/A

**Yes** Surface Condition? (G/P)

Good

N/A	Any Obstructions?	N/A	N/A	Storm Grate/Utility Hazard?	N/A
		Total Cost: \$	3200.00		Obstruction Type			Storm Grate/Utility Type	
						N/A			N/A
