Access Compliance Report

Public Rights-of-Way

(Curb Ramps)

Intersection ID: 47842	Main Street: MANITOBA_LN	Cross Street: CACTUS_VALLEY_RD	Location: NW
ADA ID: 0385BDD74154	Ramp Type: PerpDiag	Initial Pass/Fail: Fail	Overall Compliance: No
Severity Score: 12.5			
Codes/Mitigation Info/Possible Solution		Field Measurements/Component Compliance

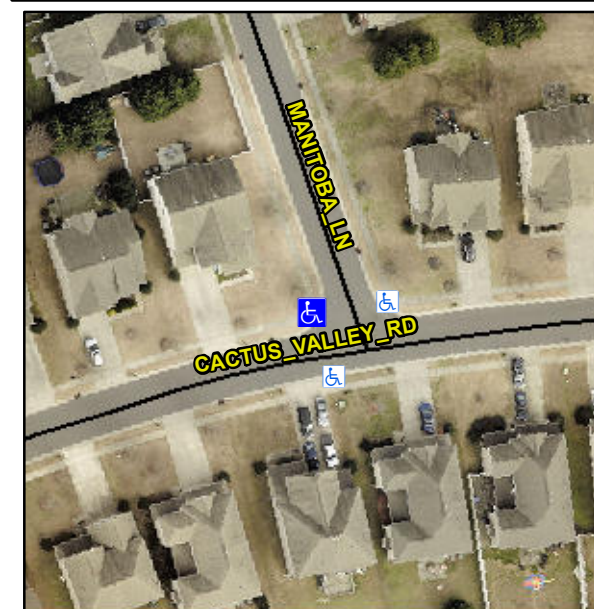
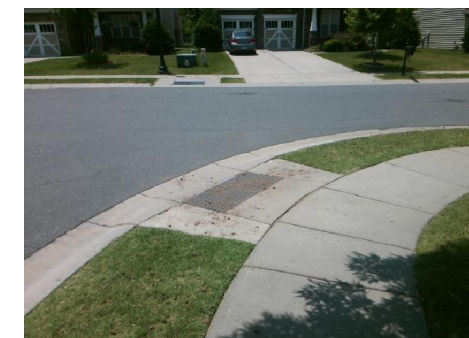
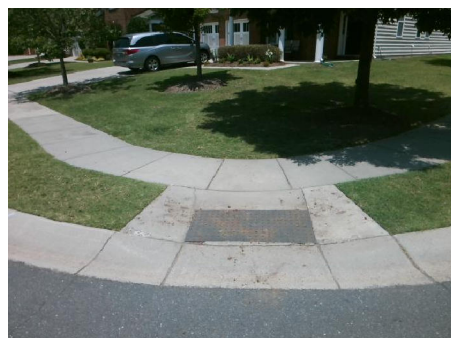
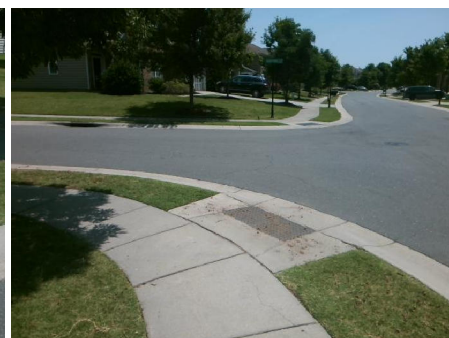
Compliance	Description	Data	Compliance	Description	Data
N/A	Ramp Length (in)	46.0	Yes	Ramp Slope (%)	5.2
Yes	Ramp Width (in)	48.0	No	Ramp XSlope (%)	5.1
N/A	Flare Type LT	N/A	N/A	Flare Type RT	N/A
N/A	Flare Slope LT (%)	N/A	N/A	Flare Slope RT (%)	N/A
N/A	Flare Traversable LT?	N/A	N/A	Flare Traversable RT?	N/A
N/A	Landing Length (in)	N/A	N/A	DWS Provided?	N/A
N/A	Landing Width (in)	N/A	N/A	DWS Contrast?	N/A
N/A	Landing Slope (%)	N/A	N/A	DWS Length (in)	N/A
N/A	Landing X Slope (%)	N/A	N/A	DWS Full Width?	N/A
N/A	Landing Curb? (Y/N)	N/A	N/A	DWS Offset (in)	N/A
N/A	Shared Landing?	N/A			
N/A	Gutter Ponding?	N/A	N/A	Gutter Slope (%)	N/A
N/A	Gutter Lip Ht (in)	N/A	N/A	Gutter X Slope (%)	N/A
N/A	Painted X Walk1?	No	N/A	Painted X Walk2?	No
	X Walk 1 Direction	To S		X Walk 2 Direction	To E
N/A	X Walk 1 Width (in)	N/A	N/A	X Walk 2 Width (in)	N/A
	X Walk 1 Slope (%)	0.0		X Walk 2 Slope (%)	1.9
	X Walk 1 X Slope (%)	1.6		X Walk 2 X Slope (%)	0.7

N/A	Ramp inside XWalk1?	N/A	N/A	Ramp inside XWalk2?	N/A
	Road Slope (%)	1.9	N/A	Clear Space?	N/A
	Road X Slope (%)	1.6	N/A	Clear Space to XWalk (in)	N/A
N/A	Any Obstructions?	N/A	N/A	Storm Grate/Utility Hazard?	N/A
	Obstruction Type			Storm Grate/Utility Type	
		N/A			N/A
		Yes		Surface Condition? (G/P)	Good

Possible Solutions:

Remove & Replace Curb Ramp With Two New Directional Ramps or Equivalent.

R304.5.3

Total Cost: \$ 3200.00
