# Access Compliance Report

## Public Rights-of-Way

### (Curb Ramps)

Intersection ID: 10033470	Main Street: OLD_PINEVILLE_RD	Cross Street: N/A	Location: NW
ADA ID: 0396212C5C1D	Ramp Type: Directional1	Initial Pass/Fail: Pass	Overall Compliance: No
Severity Score: 2.75			
Codes/Mitigation Info/Possible Solution		Field Measurements/Component Compliance

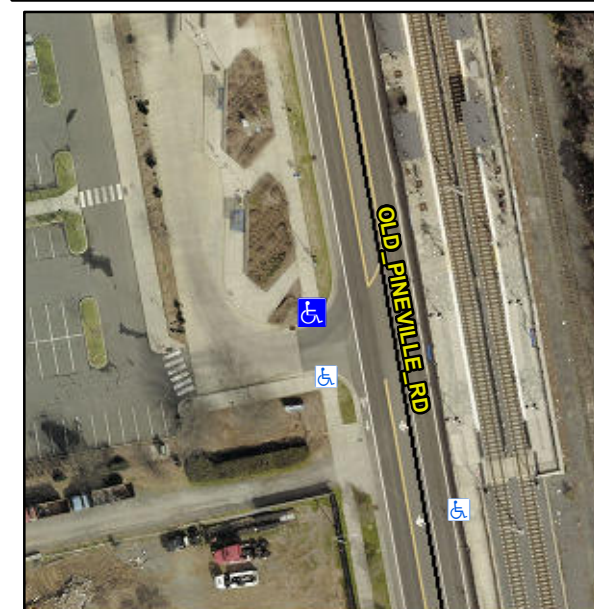
**R304.5.3, R304.5.2, R305.1.4, R305.2**

Compliance	Description	Data	Compliance	Description	Data
N/A	Ramp Length (in)	229.0	No	Grade Break?	No
Yes	Ramp Width (in)	95.0	N/A	Grade Break Slope (%)	6.0
Yes	Ramp Slope (%)	7.4	N/A	Grade Break XSlope (%)	3.5
No	Ramp XSlope (%)	3.0			
Yes	Flare Type LT	N/A	Yes	Flare Type RT	N/A
N/A	Flare Slope LT (%)	N/A	N/A	Flare Slope RT (%)	N/A
N/A	Flare Traversable LT?	No	N/A	Flare Traversable RT?	No
Yes	Landing Length (in)	60.0	Yes	DWS Provided?	Yes
Yes	Landing Width (in)	94.5	Yes	DWS Contrast?	Yes
Yes	Landing Slope (%)	1.2	Yes	DWS Length (in)	24.0
Yes	Landing X Slope (%)	1.5	No	DWS Full Width?	No
N/A	Landing Curb? (Y/N)	N/A	Yes	DWS Offset LT (in)	25.0
N/A	Shared Landing?	No	No	DWS Offset RT (in)	4.0
Yes	Gutter Ponding?	No	Yes	Gutter Slope (%)	0.6
Yes	Gutter Lip Ht (in)	0.0	Yes	Gutter X Slope (%)	1.3
N/A	Painted X Walk1?	No		Road Slope (%)	1.2
	X Walk 1 Direction	To S		Road X Slope (%)	2.2
	X Walk 1 Width (in)	N/A		Clear Space?	Yes

X Walk 1 Slope (%)	1.2	N/A	Clear Space to XWalk (in)	N/A
	X Walk 1 X Slope (%)	2.2	Yes	Storm Grate/Utility Hazard?	No
N/A	Ramp inside XWalk1?	N/A		Storm Grate/Utility Type	
Yes	Any Obstructions?	No			N/A
	Obstruction Type		Yes	Surface Condition? (G/P)	Good
			N/A	Curb Slope (%)	12.4

Possible Solutions:

**Remove & Replace Entire Ramp.**

Total Cost: \$ 1600.00

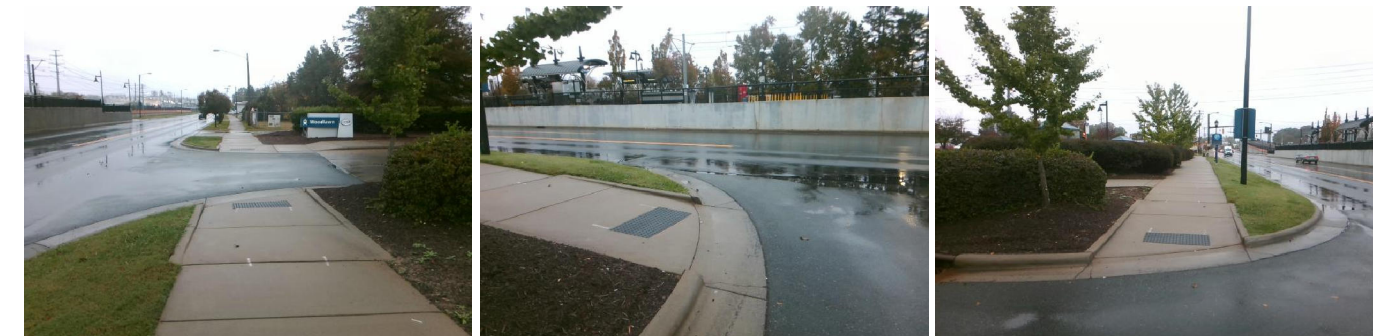
Street 1 Name	ENTRANCE
Stop Condition-Street 1	None
Street 2 Name	N/A
Stop Condition-Street 2	N/A
