# Access Compliance Report

## Public Rights-of-Way

Intersection ID: 53925	Main Street: RORY_GLEN_LN	Cross Street: PINYON_PINE_LN	Location: SE
ADA ID: 039CF21BB450	Ramp Type: PerpDiag	Initial Pass/Fail: Fail	Overall Compliance: No
Severity Score: 36.25			
Codes/Mitigation Info/Possible Solution		Field Measurements/Component Compliance

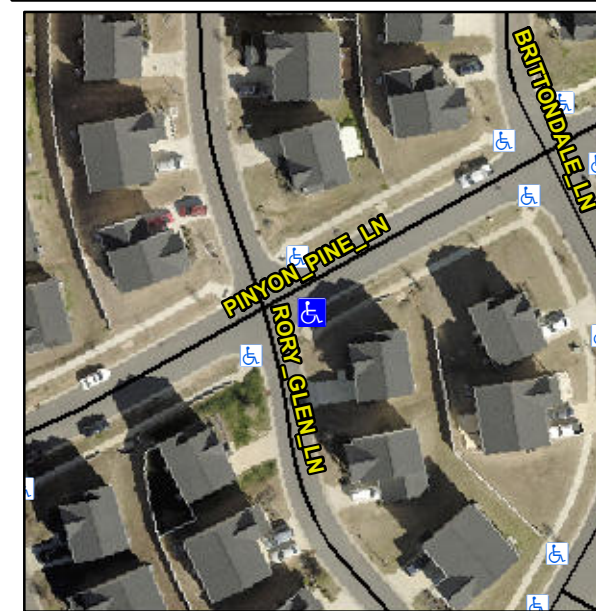
Compliance	Description	Data	Compliance	Description	Data
N/A	Ramp Length (in)	90.0	Yes	Ramp Slope (%)	6.9
No	Ramp Width (in)	24.0	No	Ramp XSlope (%)	2.3
N/A	Flare Type LT	N/A	N/A	Flare Type RT	N/A
N/A	Flare Slope LT (%)	N/A	N/A	Flare Slope RT (%)	N/A
N/A	Flare Traversable LT?	N/A	N/A	Flare Traversable RT?	N/A
N/A	Landing Length (in)	N/A	N/A	DWS Provided?	N/A
N/A	Landing Width (in)	N/A	N/A	DWS Contrast?	N/A
N/A	Landing Slope (%)	N/A	N/A	DWS Length (in)	N/A
N/A	Landing X Slope (%)	N/A	N/A	DWS Full Width?	N/A
N/A	Landing Curb? (Y/N)	N/A	N/A	DWS Offset (in)	N/A
N/A	Shared Landing?	N/A			
N/A	Gutter Ponding?	N/A	N/A	Gutter Slope (%)	N/A
N/A	Gutter Lip Ht (in)	1.0	N/A	Gutter X Slope (%)	N/A
N/A	Painted X Walk1?	No	N/A	Painted X Walk2?	No
	X Walk 1 Direction	To N		X Walk 2 Direction	To W
N/A	X Walk 1 Width (in)	N/A	N/A	X Walk 2 Width (in)	N/A
	X Walk 1 Slope (%)	5.5		X Walk 2 Slope (%)	7.8
	X Walk 1 X Slope (%)	2.8		X Walk 2 X Slope (%)	4.1

N/A	Ramp inside XWalk1?	N/A	N/A	Ramp inside XWalk2?	N/A
	Road Slope (%)	0.8	N/A	Clear Space?	N/A
	Road X Slope (%)	8.0	N/A	Clear Space to XWalk (in)	N/A
N/A	Any Obstructions?	N/A	N/A	Storm Grate/Utility Hazard?	N/A
	Obstruction Type			Storm Grate/Utility Type	
		N/A			N/A
		Yes		Surface Condition? (G/P)	Good

**Remove & Replace Curb Ramp With Two New Directional Ramps or Equivalent.**

**R304.5.1, R304.5.3**
