Access Compliance Report Public Rights-of-Way (Curb Ramps)

Intersection ID: 4066 Main Street: W_MALLARD_CREEK_CHURCICTESS Street: DAVID_TAYLOR_DR Location: N

ADA ID: 03AA31D67AF5 Ramp Type: PerpDiag Initial Pass/Fail: Fail Overall Compliance: No Severity Score: 8.75

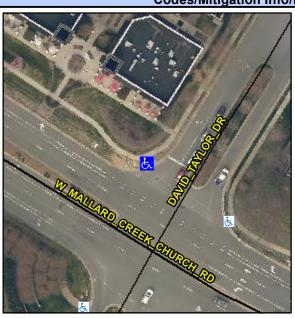
Not Found, R304.5.1

No	Ramp Width (in)	40.0	Yes	Ramp XSlope (%)
N/A	Flare Type LT	N/A	N/A	Flare Type RT
N/A	Flare Slope LT (%)	N/A	N/A	Flare Slope RT (%)
N/A	Flare Traversable LT?	N/A	N/A	Flare Traversable RT?
N/A	Landing Length (in)	N/A	N/A	DWS Provided?
N/A	Landing Width (in)	N/A	N/A	DWS Contrast?
N/A	Landing Slope (%)	N/A	N/A	DWS Length (in)
N/A	Landing X Slope (%)	N/A	N/A	DWS Full Width?
N/A	Landing Curb? (Y/N)	N/A	N/A	DWS Offset (in)
N/A	Shared Landing?	N/A		
N/A	Gutter Ponding?	N/A	N/A	Gutter Slope (%)
N/A	Gutter Lip Ht (in)	N/A	N/A	Gutter X Slope (%)
N/A	Painted X Walk1?	No	N/A	Painted X Walk2?
	X Walk 1 Direction	To SW		X Walk 2 Direction
N/A	X Walk 1 Width (in)	N/A	N/A	X Walk 2 Width (in)
	X Walk 1 Slope (%)	3.2		X Walk 2 Slope (%)
	X Walk 1 X Slope (%)	1.4		X Walk 2 X Slope (%)
N/A	Ramp inside XWalk1?	N/A	N/A	Ramp inside XWalk2?
	Road Slope (%)	1.6	N/A	Clear Space?
	Road X Slope (%)	2.7	N/A	Clear Space to XWalk (in)
N/A	Any Obstructions?	N/A	N/A	Storm Grate/Utility Hazard?

Remove & Replace Curb Ramp With Two New Directional Ramps or Equivalent.
