Access Compliance Report

Public Rights-of-Way

(Curb Ramps)

Intersection ID: 2840	Main Street: ANNBICK_LN	Cross Street: BELL'S_MILL_DR	Location:	N
ADA ID: 03AA756EDE38	Ramp Type: BlendTrans1	Initial Pass/Fail: Fail	Overall Compliance: No	Severity Score: 12.5
Codes/Mitigation Info/Possible Solution		Field Measurements/Component Compliance

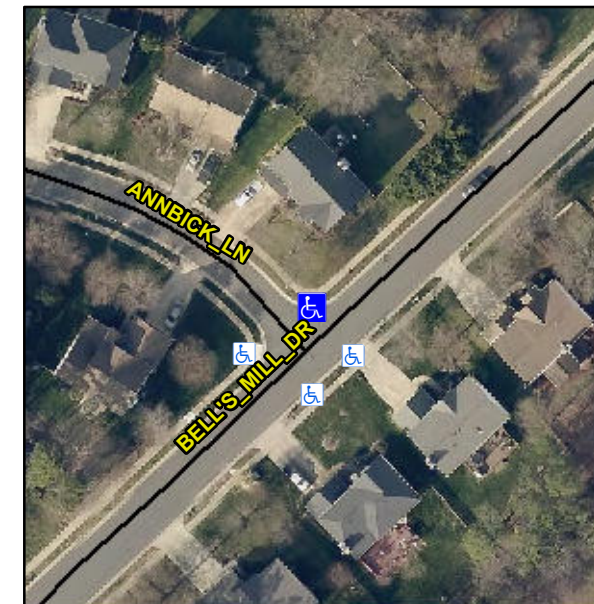
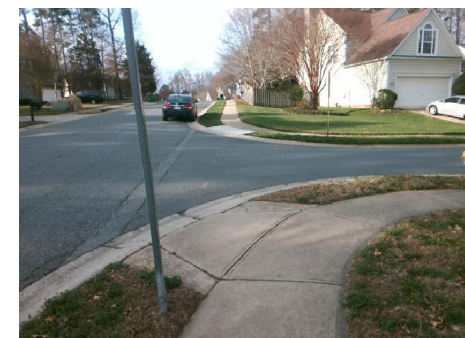
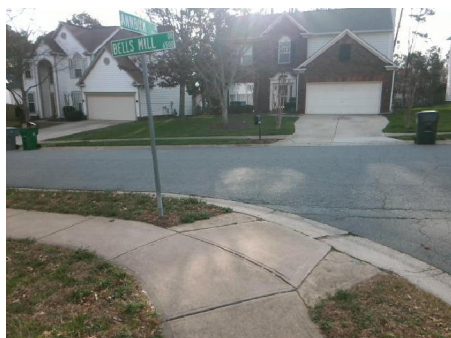
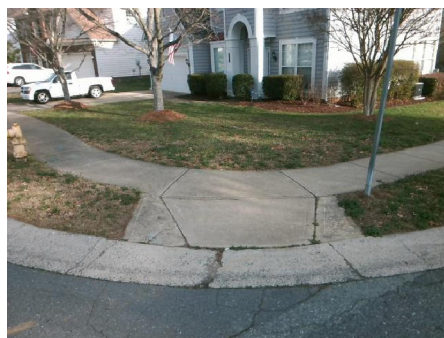
DAMAGED LT FL/GTR

Not Found, R304.5.3

Compliance	Description	Data	Compliance	Description	Data
N/A	Ramp Length (in)	46.0	Yes	BlendTrans Slope (%)	4.2
Yes	Ramp Width (in)	52.0	No	BlendTrans XSlope (%)	5.3
N/A	Flare Type LT	N/A	N/A	Flare Type RT	N/A
N/A	Flare Slope LT (%)	N/A	N/A	Flare Slope RT (%)	N/A
N/A	Flare Traversable LT?	N/A	N/A	Flare Traversable RT?	N/A
N/A	Landing Length (in)	N/A	N/A	DWS Provided?	N/A
N/A	Landing Width (in)	N/A	N/A	DWS Contrast?	N/A
N/A	Landing Slope (%)	N/A	N/A	DWS Length (in)	N/A
N/A	Landing X Slope (%)	N/A	N/A	DWS Full Width?	N/A
N/A	Landing Curb? (Y/N)	N/A	N/A	DWS Offset (in)	N/A
N/A	Shared Landing?	N/A			
N/A	Gutter Ponding?	N/A	N/A	Gutter Slope (%)	N/A
N/A	Gutter Lip Ht (in)	1.0	N/A	Gutter X Slope (%)	N/A
N/A	Painted X Walk1?	No	N/A	Painted X Walk2?	No
	X Walk 1 Direction	To SW		X Walk 2 Direction	To SE
	X Walk 1 Width (in)	N/A		X Walk 2 Width (in)	N/A
	X Walk 1 Slope (%)	5.1		X Walk 2 Slope (%)	3.3
	X Walk 1 X Slope (%)	3.1		X Walk 2 X Slope (%)	5.7

N/A	Ramp inside XWalk1?	N/A	N/A	Ramp inside XWalk2?	N/A
	Road Slope (%)	3.3		Clear Space?	N/A
	Road X Slope (%)	8.2	N/A	Clear Space to XWalk (in)	N/A
N/A	Any Obstructions?	N/A	N/A	Storm Grate/Utility Hazard?	N/A
	Obstruction Type			Storm Grate/Utility Type	
		N/A			N/A
			Yes	Surface Condition? (G/P)	Good
			No	Curb Slope (%)	12.0

Remove & Replace Curb Ramp With Two New Directional Ramps or Equivalent.
