# Access Compliance Report

## Public Rights-of-Way

### (Curb Ramps)

Intersection ID: 27871	Main Street: HARRISON'S CROSSING_AV	Cross Street: STRICKLAND_CT	Location: E
ADA ID: 03B23D0D72B1	Ramp Type: Perp	Initial Pass/Fail: Fail	Overall Compliance: No
Severity Score: 26.25			
Codes/Mitigation Info/Possible Solution		Field Measurements/Component Compliance

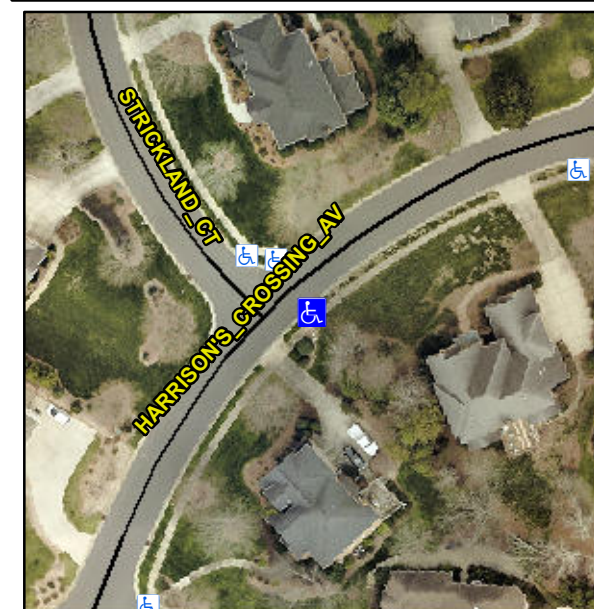
**Not Found, R304.2.2, R304.5.3**

Compliance	Description	Data	Compliance	Description	Data
N/A	Ramp Length (in)	36.0	No	Ramp Slope (%)	14.1
Yes	Ramp Width (in)	48.0	No	Ramp XSlope (%)	4.3
N/A	Flare Type LT	N/A	N/A	Flare Type RT	N/A
N/A	Flare Slope LT (%)	N/A	N/A	Flare Slope RT (%)	N/A
N/A	Flare Traversable LT?	N/A	N/A	Flare Traversable RT?	N/A
N/A	Landing Length (in)	N/A	N/A	DWS Provided?	N/A
N/A	Landing Width (in)	N/A	N/A	DWS Contrast?	N/A
N/A	Landing Slope (%)	N/A	N/A	DWS Length (in)	N/A
N/A	Landing X Slope (%)	N/A	N/A	DWS Full Width?	N/A
N/A	Landing Curb? (Y/N)	N/A	N/A	DWS Offset (in)	N/A
N/A	Shared Landing?	N/A			
N/A	Gutter Ponding?	N/A	N/A	Gutter Slope (%)	N/A
N/A	Gutter Lip Ht (in)	N/A	N/A	Gutter X Slope (%)	N/A
N/A	Painted X Walk1?	No	N/A	Painted X Walk2?	N/A
	X Walk 1 Direction	To NW		X Walk 2 Direction	N/A
N/A	X Walk 1 Width (in)	N/A	N/A	X Walk 2 Width (in)	N/A
	X Walk 1 Slope (%)	3.1		X Walk 2 Slope (%)	N/A
	X Walk 1 X Slope (%)	2.3		X Walk 2 X Slope (%)	N/A

N/A	Ramp inside XWalk1?	N/A	N/A	Ramp inside XWalk2?	N/A
	Road Slope (%)	N/A	N/A	Clear Space?	N/A
	Road X Slope (%)	N/A	N/A	Clear Space to XWalk (in)	N/A
N/A	Any Obstructions?	N/A	N/A	Storm Grate/Utility Hazard?	N/A
	Obstruction Type			Storm Grate/Utility Type	
		N/A			N/A
			Yes	Surface Condition? (G/P)	Good

**Remove & Replace Entire Ramp.**

Total Cost: \$ 1850.00
