## **Access Compliance Report Public Rights-of-Way** (Curb Ramps)

Intersection ID: 11747 Main Street: W\_10TH\_ST Cross Street: N\_TRYON\_ST Location: N **ADA ID: 03BE17E080DE** Ramp Type: PerpDiag Initial Pass/Fail: Fail **Overall Compliance: No Severity Score:** 12.5

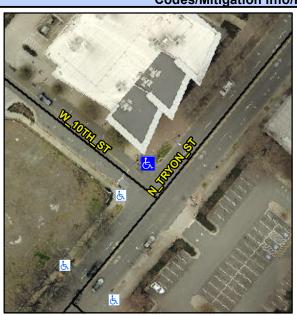
| Compliance Description Da | | Data | Compliance Description | | Data |
|---|---|---|---|---|---|
| N/A | Ramp Length (in) | 78.0 | No | Ramp Slope (%) | 10.8 |

Possible Solutions: Remove & Replace Curb Ramp With **Two New Directional Ramps or** Equivalent. Surveyor Notes: N/A

PROW/ADA: R304.2.2
