# Access Compliance Report

## Public Rights-of-Way

### (Curb Ramps)

Intersection ID: 10038833	Main Street: STEELECROFT_PY	Cross Street: N/A	Location: S
ADA ID: 03BE32B815D4	Ramp Type: PerpDiag	Initial Pass/Fail: Fail	Overall Compliance: No
Severity Score: 21.25			
Codes/Mitigation Info/Possible Solution		Field Measurements/Component Compliance

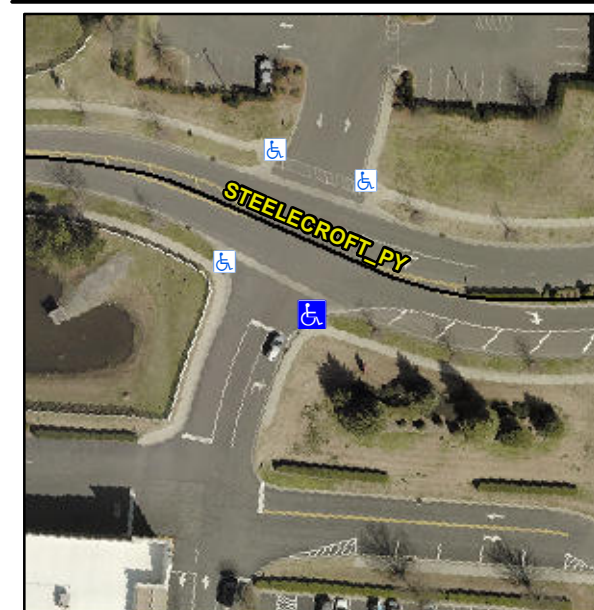
**Not Found, R304.5.1, R304.5.3**

Compliance	Description	Data	Compliance	Description	Data
N/A	Ramp Length (in)	72.0	Yes	Ramp Slope (%)	7.9
No	Ramp Width (in)	47.5	No	Ramp XSlope (%)	5.1
N/A	Flare Type LT	N/A	N/A	Flare Type RT	N/A
N/A	Flare Slope LT (%)	N/A	N/A	Flare Slope RT (%)	N/A
N/A	Flare Traversable LT?	N/A	N/A	Flare Traversable RT?	N/A
N/A	Landing Length (in)	N/A	N/A	DWS Provided?	N/A
N/A	Landing Width (in)	N/A	N/A	DWS Contrast?	N/A
N/A	Landing Slope (%)	N/A	N/A	DWS Length (in)	N/A
N/A	Landing X Slope (%)	N/A	N/A	DWS Full Width?	N/A
N/A	Landing Curb? (Y/N)	N/A	N/A	DWS Offset (in)	N/A
N/A	Shared Landing?	N/A			
N/A	Gutter Ponding?	N/A	N/A	Gutter Slope (%)	N/A
N/A	Gutter Lip Ht (in)	N/A	N/A	Gutter X Slope (%)	N/A
N/A	Painted X Walk1?	No	N/A	Painted X Walk2?	No
	X Walk 1 Direction	To NE		X Walk 2 Direction	To NW
N/A	X Walk 1 Width (in)	N/A	N/A	X Walk 2 Width (in)	N/A
	X Walk 1 Slope (%)	2.5		X Walk 2 Slope (%)	2.6
	X Walk 1 X Slope (%)	2.3		X Walk 2 X Slope (%)	4.5

N/A	Ramp inside XWalk1?	N/A	N/A	Ramp inside XWalk2?	N/A
	Road Slope (%)	5.4	N/A	Clear Space?	N/A
	Road X Slope (%)	0.7	N/A	Clear Space to XWalk (in)	N/A
N/A	Any Obstructions?	N/A	N/A	Storm Grate/Utility Hazard?	N/A
	Obstruction Type			Storm Grate/Utility Type	
		N/A			N/A
			Yes	Surface Condition? (G/P)	Good

Possible Solutions:

**Remove & Replace Curb Ramp With Two New Directional Ramps or Equivalent.**
