Access Compliance Report

Public Rights-of-Way

(Curb Ramps)

Intersection ID: 12080	Main Street: E_15TH_ST	Cross Street: SEIGLE_AV	Location: W
ADA ID: 03EDC675F00A	Ramp Type: Perp	Initial Pass/Fail: Fail	Overall Compliance: No
Severity Score: 8.75			
Codes/Mitigation Info/Possible Solution		Field Measurements/Component Compliance

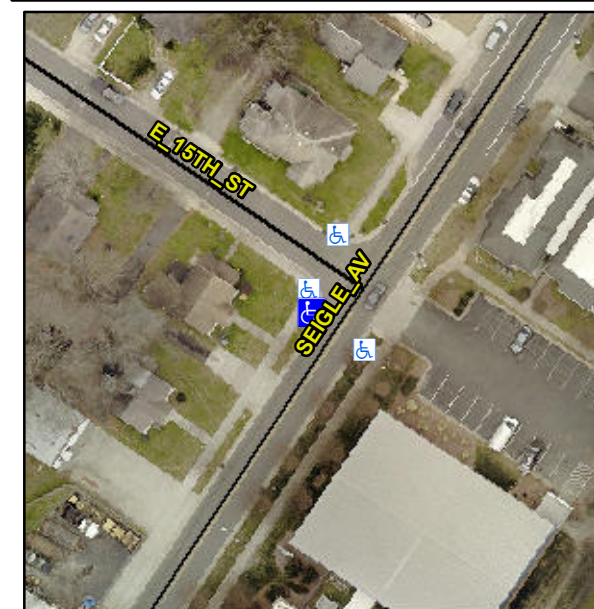
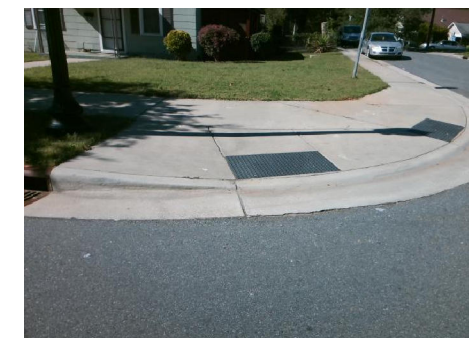
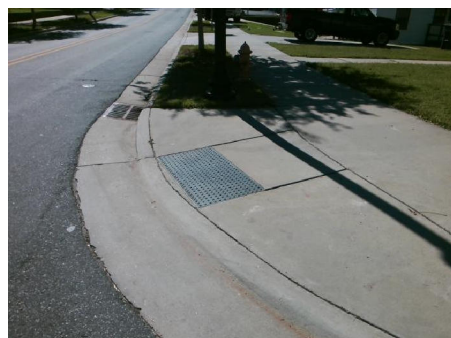
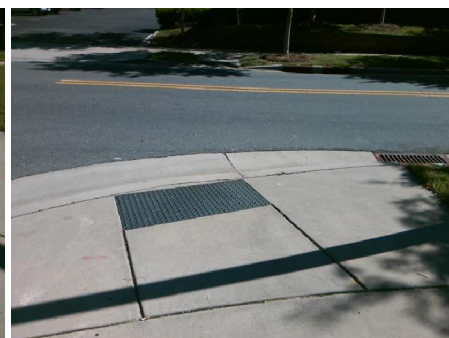
Not Found, R304.5.1

Compliance	Description	Data	Compliance	Description	Data
N/A	Ramp Length (in)	61.0	Yes	Ramp Slope (%)	5.0
No	Ramp Width (in)	47.5	Yes	Ramp XSlope (%)	1.3
N/A	Flare Type LT	N/A	N/A	Flare Type RT	N/A
N/A	Flare Slope LT (%)	N/A	N/A	Flare Slope RT (%)	N/A
N/A	Flare Traversable LT?	N/A	N/A	Flare Traversable RT?	N/A
N/A	Landing Length (in)	N/A	N/A	DWS Provided?	N/A
N/A	Landing Width (in)	N/A	N/A	DWS Contrast?	N/A
N/A	Landing Slope (%)	N/A	N/A	DWS Length (in)	N/A
N/A	Landing X Slope (%)	N/A	N/A	DWS Full Width?	N/A
N/A	Landing Curb? (Y/N)	N/A	N/A	DWS Offset (in)	N/A
N/A	Shared Landing?	N/A			
N/A	Gutter Ponding?	N/A	N/A	Gutter Slope (%)	N/A
N/A	Gutter Lip Ht (in)	N/A	N/A	Gutter X Slope (%)	N/A
N/A	Painted X Walk1?	No	N/A	Painted X Walk2?	N/A
	X Walk 1 Direction	To SE		X Walk 2 Direction	N/A
N/A	X Walk 1 Width (in)	N/A	N/A	X Walk 2 Width (in)	N/A
	X Walk 1 Slope (%)	0.9		X Walk 2 Slope (%)	N/A
	X Walk 1 X Slope (%)	1.6		X Walk 2 X Slope (%)	N/A

N/A	Ramp inside XWalk1?	N/A	N/A	Ramp inside XWalk2?	N/A
	Road Slope (%)	N/A	N/A	Clear Space?	N/A
	Road X Slope (%)	N/A	N/A	Clear Space to XWalk (in)	N/A
N/A	Any Obstructions?	N/A	N/A	Storm Grate/Utility Hazard?	N/A
	Obstruction Type			Storm Grate/Utility Type	
		N/A			N/A
			Yes	Surface Condition? (G/P)	Good

Possible Solutions:

Remove & Replace Entire Ramp.
