Access Compliance Report

Public Rights-of-Way

(Curb Ramps)

Intersection ID: 15174	Main Street: DILWORTH_RD_WEST	Cross Street: IDEAL_WY	Location: SW
ADA ID: 03EE4D6AB4C0	Ramp Type: Perp	Initial Pass/Fail: Fail	Overall Compliance: No
Severity Score: 13.75			
Codes/Mitigation Info/Possible Solution		Field Measurements/Component Compliance

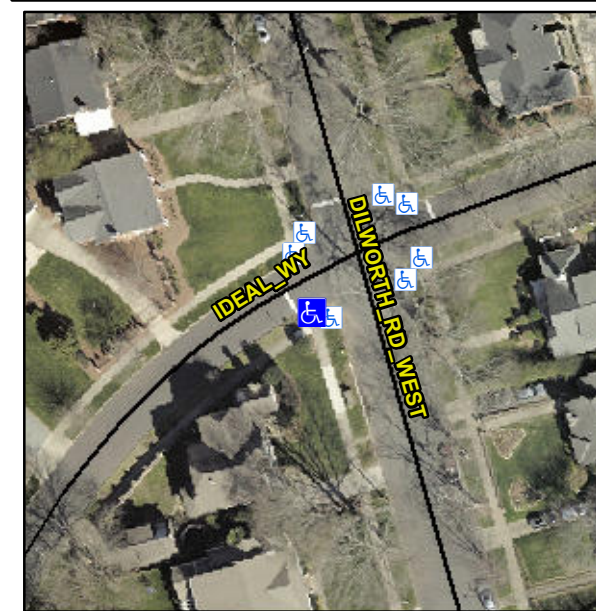
Not Found, R304.2.2, R304.5.3

Compliance	Description	Data	Compliance	Description	Data
N/A	Ramp Length (in)	81.0	No	Ramp Slope (%)	8.9
Yes	Ramp Width (in)	72.0	No	Ramp XSlope (%)	4.0
N/A	Flare Type LT	N/A	N/A	Flare Type RT	N/A
N/A	Flare Slope LT (%)	N/A	N/A	Flare Slope RT (%)	N/A
N/A	Flare Traversable LT?	N/A	N/A	Flare Traversable RT?	N/A
N/A	Landing Length (in)	N/A	N/A	DWS Provided?	N/A
N/A	Landing Width (in)	N/A	N/A	DWS Contrast?	N/A
N/A	Landing Slope (%)	N/A	N/A	DWS Length (in)	N/A
N/A	Landing X Slope (%)	N/A	N/A	DWS Full Width?	N/A
N/A	Landing Curb? (Y/N)	N/A	N/A	DWS Offset (in)	N/A
N/A	Shared Landing?	N/A			
N/A	Gutter Ponding?	N/A	N/A	Gutter Slope (%)	N/A
N/A	Gutter Lip Ht (in)	N/A	N/A	Gutter X Slope (%)	N/A
N/A	Painted X Walk1?	No	N/A	Painted X Walk2?	N/A
	X Walk 1 Direction	To N		X Walk 2 Direction	N/A
N/A	X Walk 1 Width (in)	N/A	N/A	X Walk 2 Width (in)	N/A
	X Walk 1 Slope (%)	5.1		X Walk 2 Slope (%)	N/A
	X Walk 1 X Slope (%)	4.2		X Walk 2 X Slope (%)	N/A

N/A	Ramp inside XWalk1?	N/A	N/A	Ramp inside XWalk2?	N/A
	Road Slope (%)	N/A	N/A	Clear Space?	N/A
	Road X Slope (%)	N/A	N/A	Clear Space to XWalk (in)	N/A
N/A	Any Obstructions?	N/A	N/A	Storm Grate/Utility Hazard?	N/A
	Obstruction Type			Storm Grate/Utility Type	
		N/A			N/A
			Yes	Surface Condition? (G/P)	Good

Remove & Replace Entire Ramp.
