Access Compliance Report

Public Rights-of-Way

(Curb Ramps)

Intersection ID: 10015568	Main Street: CARMINE_ST	Cross Street: N/A	Location: NE
ADA ID: 03FEB383D8A9	Ramp Type: ParaDiag	Initial Pass/Fail: Fail	Overall Compliance: No
Codes/Mitigation Info/Possible Solution		Field Measurements/Component Compliance

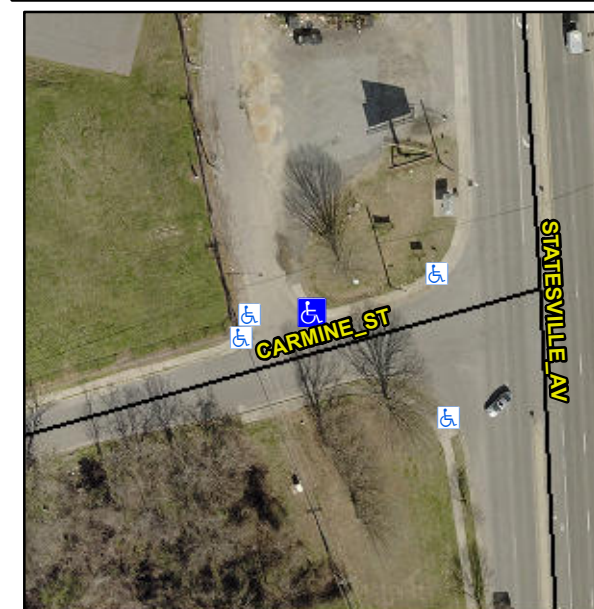
R304.3.2, R304.5.3

Compliance	Description	Data	Compliance	Description	Data
N/A	Ramp Length LT (in)	52.0	N/A	Ramp Length RT (in)	53.0
Yes	Ramp Width LT (in)	58.0	Yes	Ramp Width RT (in)	60.0
No	Ramp Slope LT (%)	11.6	Yes	Ramp Slope RT (%)	7.8
No	Ramp XSlope LT (%)	3.8	No	Ramp XSlope RT (%)	2.5
N/A	Landing Length (in)	N/A	N/A	DWS Provided?	N/A
N/A	Landing Width (in)	N/A	N/A	DWS Contrast?	N/A
N/A	Landing Slope (%)	N/A	N/A	DWS Length (in)	N/A
N/A	Landing X Slope (%)	N/A	N/A	DWS Full Width?	N/A
N/A	Landing Curb? (Y/N)	N/A	N/A	DWS Offset (in)	N/A
N/A	Shared Landing?	N/A			
N/A	Gutter Ponding?	N/A	N/A	Gutter Slope (%)	N/A
N/A	Gutter Lip Ht (in)	N/A	N/A	Gutter X Slope (%)	N/A
N/A	Painted X Walk1?	No	N/A	Painted X Walk2?	No
	X Walk 1 Direction	To W		X Walk 2 Direction	To S
N/A	X Walk 1 Width (in)	N/A	N/A	X Walk 2 Width (in)	N/A
	X Walk 1 Slope (%)	1.7		X Walk 2 Slope (%)	2.4
	X Walk 1 X Slope (%)	3.1		X Walk 2 X Slope (%)	0.5
N/A	Ramp inside XWalk1?	N/A	N/A	Ramp inside XWalk2?	N/A

Road Slope (%)	1.6	N/A	Clear Space?	N/A
	Road X Slope (%)	3.2	N/A	Clear Space to XWalk (in)	N/A
N/A	Any Obstructions?	N/A	N/A	Storm Grate/Utility Hazard?	N/A
	Obstruction Type			Storm Grate/Utility Type	
		N/A			N/A
			Yes	Surface Condition? (G/P)	Good
			N/A	Curb Slope (%)	0.5

Remove & Replace Curb Ramp With Two New Directional Ramps or Equivalent.
