# Access Compliance Report

## Public Rights-of-Way

### (Curb Ramps)

| Intersection ID: N/A | Main Street: BLAKENEY PROFESSIONAL DR | Cross Street: N/A | Location: NE |

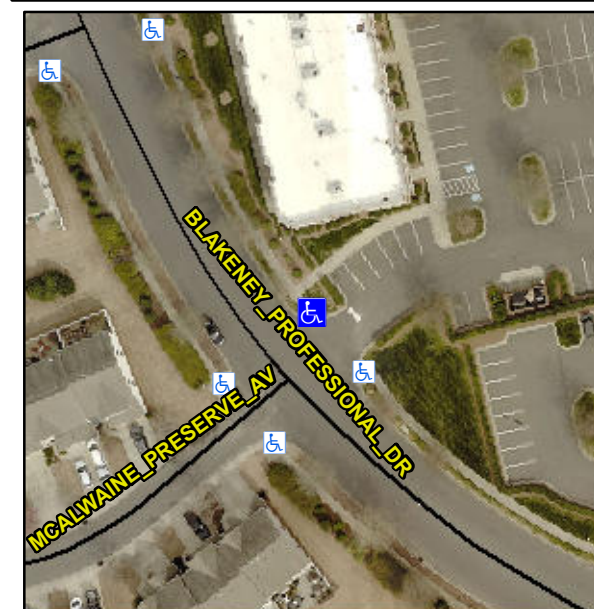
| ADA ID: 04016F9D6E81 | Ramp Type: PerpDiag | Initial Pass/Fail: Fail | Overall Compliance: No |

**R304.5.1**

| Compliance | Description | Data | Compliance | Description | Data |
|---|---|---|---|---|---|
| No | Ramp Width (in) | 37.0 | Yes | Ramp XSlope (%) | 2.0 |

**Remove & Replace Curb Ramp With Two New Directional Ramps or Equivalent.**
