# Access Compliance Report

## Public Rights-of-Way

### (Curb Ramps)

Intersection ID: 42363	Main Street: CONDOR_CR	Cross Street: KESTRAL_RIDGE_DR	Location: SW
ADA ID: 040600C726F0	Ramp Type: BlendTrans1	Initial Pass/Fail: Pass	Overall Compliance: No
		Severity Score: 10

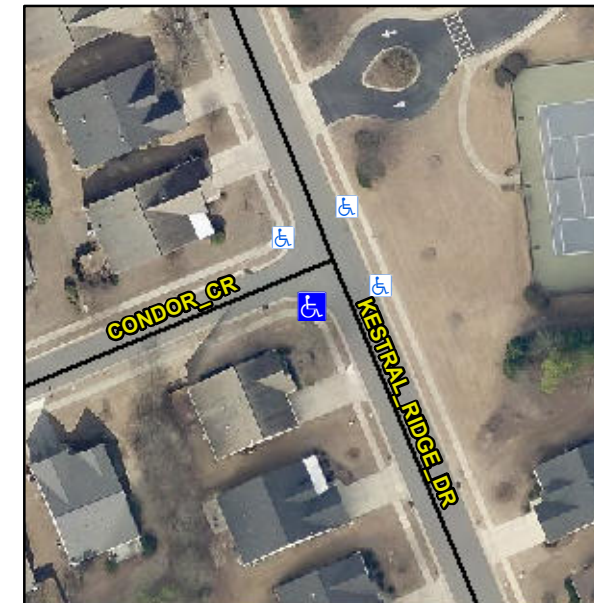
**Not Found, R304.2.2-Perp, R304.3.2-Para, R304.5.3, R305**

Compliance	Description	Data	Compliance	Description	Data
N/A	Ramp Length (in)	47.0	Yes	BlendTrans Slope (%)	3.4
Yes	Ramp Width (in)	62.5	Yes	BlendTrans XSlope (%)	1.9
N/A	Flare Type LT	Sloped	N/A	Flare Type RT	Sloped
N/A	Flare Slope LT (%)	3.9	N/A	Flare Slope RT (%)	4.2
N/A	Flare Traversable LT?	No	N/A	Flare Traversable RT?	No
Yes	Landing Length (in)	48.0	No	DWS Provided?	No
Yes	Landing Width (in)	50.0	N/A	DWS Contrast?	No
No	Landing Slope (%)	4.3	N/A	DWS Length (in)	N/A
No	Landing X Slope (%)	3.2	N/A	DWS Full Width?	No
N/A	Landing Curb? (Y/N)	No	N/A	DWS Offset (in)	N/A
N/A	Shared Landing?	No			
Yes	Gutter Ponding?	No	Yes	Gutter Slope (%)	3.7
Yes	Gutter Lip Ht (in)	0.0	Yes	Gutter X Slope (%)	1.5
N/A	Painted X Walk1?	No	N/A	Painted X Walk2?	No
	X Walk 1 Direction	To E		X Walk 2 Direction	To NW
	X Walk 1 Width (in)	N/A		X Walk 2 Width (in)	N/A
	X Walk 1 Slope (%)	2.1		X Walk 2 Slope (%)	1.8
	X Walk 1 X Slope (%)	2.3		X Walk 2 X Slope (%)	0.5

N/A	Ramp inside XWalk1?	N/A	N/A	Ramp inside XWalk2?	N/A
	Road Slope (%)	2.1		Clear Space?	Yes
	Road X Slope (%)	1.7	N/A	Clear Space to XWalk (in)	N/A
Yes	Any Obstructions?	No	Yes	Storm Grate/Utility Hazard?	No
	Obstruction Type			Storm Grate/Utility Type	
		N/A			N/A
			Yes	Surface Condition? (G/P)	Good
			No	Curb Slope (%)	24.8

**Remove & Replace Curb Ramp With Two New Directional Ramps or Equivalent.**

Total Cost: \$ 3200.00
