Access Compliance Report

Public Rights-of-Way

(Curb Ramps)

Intersection ID: 53351	Main Street: MARVIN_RD	Cross Street: SAPPHIRE_HILL_LN	Location: SW
ADA ID: 040A1E241E77	Ramp Type: Perp	Initial Pass/Fail: Fail	Overall Compliance: No
		Severity Score: 8.75

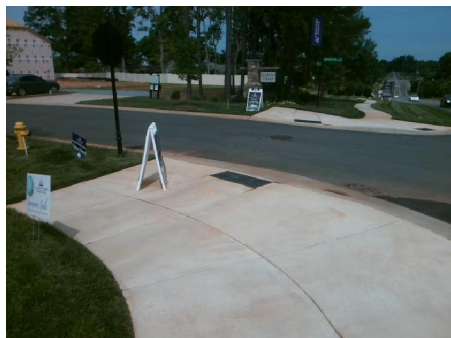
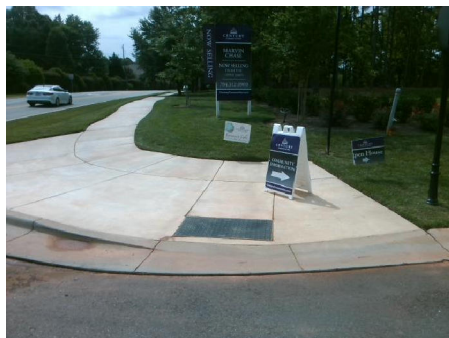
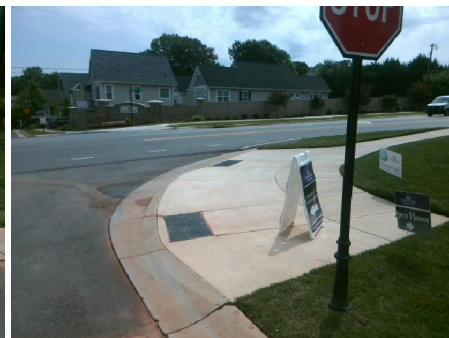
Compliance	Description	Data	Compliance	Description	Data
N/A	Ramp Length (in)	101.0	Yes	Ramp Slope (%)	5.9
No	Ramp Width (in)	47.0	Yes	Ramp XSlope (%)	1.4
N/A	Flare Type LT	N/A	N/A	Flare Type RT	N/A
N/A	Flare Slope LT (%)	N/A	N/A	Flare Slope RT (%)	N/A
N/A	Flare Traversable LT?	N/A	N/A	Flare Traversable RT?	N/A
N/A	Landing Length (in)	N/A	N/A	DWS Provided?	N/A
N/A	Landing Width (in)	N/A	N/A	DWS Contrast?	N/A
N/A	Landing Slope (%)	N/A	N/A	DWS Length (in)	N/A
N/A	Landing X Slope (%)	N/A	N/A	DWS Full Width?	N/A
N/A	Landing Curb? (Y/N)	N/A	N/A	DWS Offset (in)	N/A
N/A	Shared Landing?	N/A			
N/A	Gutter Ponding?	N/A	N/A	Gutter Slope (%)	N/A
N/A	Gutter Lip Ht (in)	N/A	N/A	Gutter X Slope (%)	N/A
N/A	Painted X Walk1?	No	N/A	Painted X Walk2?	N/A
	X Walk 1 Direction	To NW		X Walk 2 Direction	N/A
N/A	X Walk 1 Width (in)	N/A	N/A	X Walk 2 Width (in)	N/A
	X Walk 1 Slope (%)	2.9		X Walk 2 Slope (%)	N/A
	X Walk 1 X Slope (%)	2.3		X Walk 2 X Slope (%)	N/A

N/A	Ramp inside XWalk1?	N/A	N/A	Ramp inside XWalk2?	N/A
	Road Slope (%)	N/A	N/A	Clear Space?	N/A
	Road X Slope (%)	N/A	N/A	Clear Space to XWalk (in)	N/A
N/A	Any Obstructions?	N/A	N/A	Storm Grate/Utility Hazard?	N/A
	Obstruction Type			Storm Grate/Utility Type	
		N/A			N/A
			Yes	Surface Condition? (G/P)	Good

Possible Solutions:

Remove & Replace Entire Ramp.
