# Access Compliance Report

## Public Rights-of-Way

### (Curb Ramps)

Intersection ID: 8157	Main Street: N_TRYON_ST	Cross Street: ORR_RD	Location: SE
ADA ID: 044FB9957631	Ramp Type: Perp	Initial Pass/Fail: Fail	Overall Compliance: No
Severity Score: 8.75			
Codes/Mitigation Info/Possible Solution		Field Measurements/Component Compliance

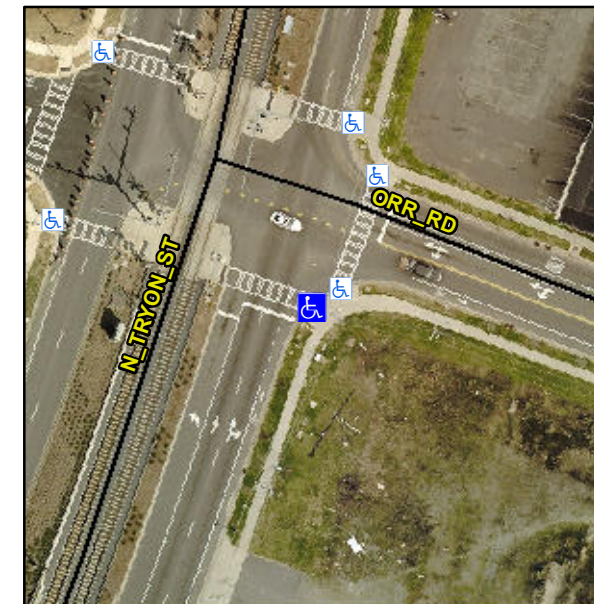
**Not Found, R304.5.1**

Compliance	Description	Data	Compliance	Description	Data
N/A	Ramp Length (in)	99.0	Yes	Ramp Slope (%)	6.4
No	Ramp Width (in)	47.0	Yes	Ramp XSlope (%)	1.4
N/A	Flare Type LT	N/A	N/A	Flare Type RT	N/A
N/A	Flare Slope LT (%)	N/A	N/A	Flare Slope RT (%)	N/A
N/A	Flare Traversable LT?	N/A	N/A	Flare Traversable RT?	N/A
N/A	Landing Length (in)	N/A	N/A	DWS Provided?	N/A
N/A	Landing Width (in)	N/A	N/A	DWS Contrast?	N/A
N/A	Landing Slope (%)	N/A	N/A	DWS Length (in)	N/A
N/A	Landing X Slope (%)	N/A	N/A	DWS Full Width?	N/A
N/A	Landing Curb? (Y/N)	N/A	N/A	DWS Offset (in)	N/A
N/A	Shared Landing?	N/A			
N/A	Gutter Ponding?	N/A	N/A	Gutter Slope (%)	N/A
N/A	Gutter Lip Ht (in)	N/A	N/A	Gutter X Slope (%)	N/A
N/A	Painted X Walk1?	Yes	N/A	Painted X Walk2?	N/A
	X Walk 1 Direction	To W		X Walk 2 Direction	N/A
N/A	X Walk 1 Width (in)	104.0	N/A	X Walk 2 Width (in)	N/A
	X Walk 1 Slope (%)	4.2		X Walk 2 Slope (%)	N/A
	X Walk 1 X Slope (%)	0.5		X Walk 2 X Slope (%)	N/A

N/A	Ramp inside XWalk1?	Yes	N/A	Ramp inside XWalk2?	N/A
	Road Slope (%)	N/A	N/A	Clear Space?	N/A
	Road X Slope (%)	N/A	N/A	Clear Space to XWalk (in)	N/A
N/A	Any Obstructions?	N/A	N/A	Storm Grate/Utility Hazard?	N/A
	Obstruction Type			Storm Grate/Utility Type	
		N/A			N/A
		Yes		Surface Condition? (G/P)	Good

**Remove & Replace Entire Ramp.**

Total Cost: \$ 1850.00
