# Access Compliance Report

## Public Rights-of-Way

### (Curb Ramps)

| Intersection ID: 50998 | Main Street: S_TRYON_ST | Cross Street: STEELECROFT_PY | Location: NW |

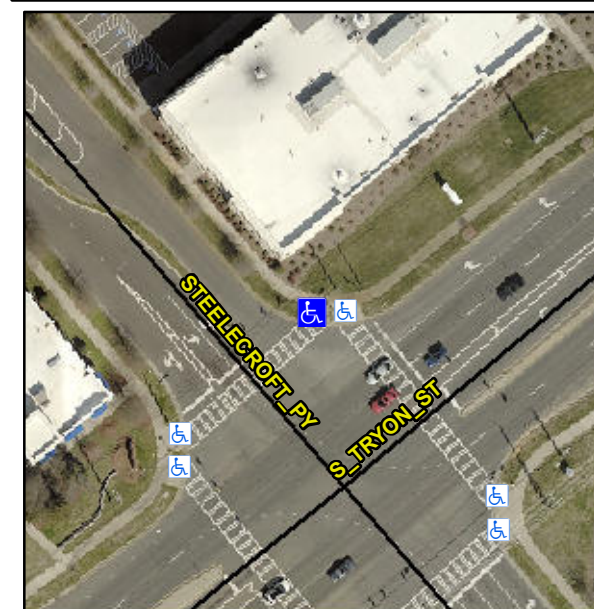
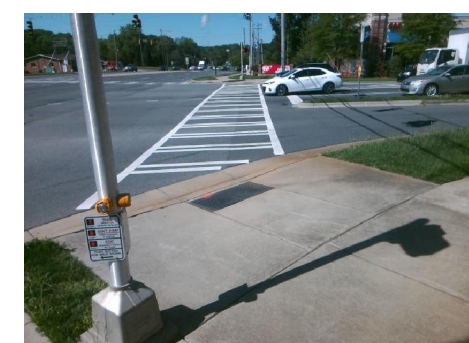
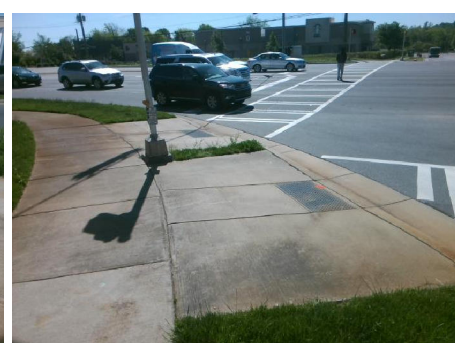
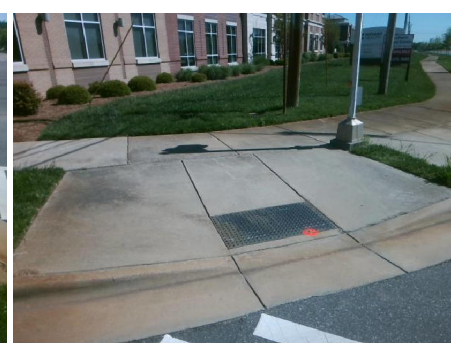
**Not Found, R304.5.1, R304.2.2**

| Compliance | Description | Data | Compliance | Description | Data |
|---|---|---|---|---|---|
| N/A | Ramp Length (in) | 97.0 | No | Ramp Slope (%) | 12.1 |
| No | Ramp Width (in) | 45.5 | Yes | Ramp XSlope (%) | 4.7 |

**Remove & Replace Entire Ramp.**
