Access Compliance Report

Public Rights-of-Way

(Curb Ramps)

Intersection ID: 18036	Main Street: INWOOD_DR	Cross Street: SOUTH_BV	Location: NE
ADA ID: 045D7DF78F09	Ramp Type: PerpDiag	Initial Pass/Fail: Fail	Overall Compliance: No
Severity Score: 13.75			
Codes/Mitigation Info/Possible Solution		Field Measurements/Component Compliance

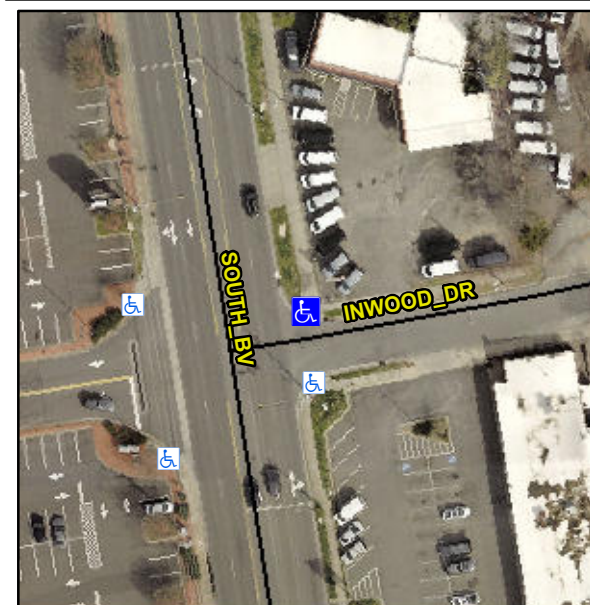
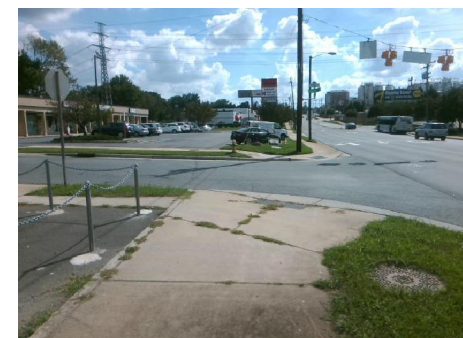
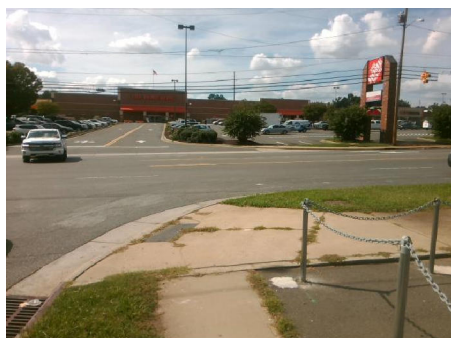
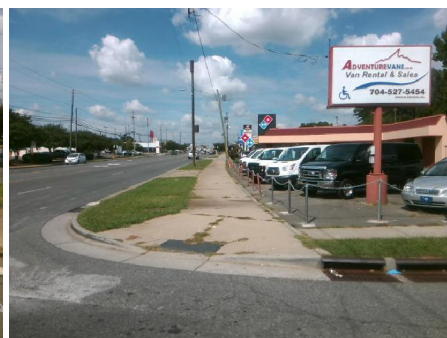
R304.2.2, R304.5.3

Compliance	Description	Data	Compliance	Description	Data
N/A	Ramp Length (in)	74.0	No	Ramp Slope (%)	9.9
Yes	Ramp Width (in)	48.0	No	Ramp XSlope (%)	4.3
N/A	Flare Type LT	N/A	N/A	Flare Type RT	N/A
N/A	Flare Slope LT (%)	N/A	N/A	Flare Slope RT (%)	N/A
N/A	Flare Traversable LT?	N/A	N/A	Flare Traversable RT?	N/A
N/A	Landing Length (in)	N/A	N/A	DWS Provided?	N/A
N/A	Landing Width (in)	N/A	N/A	DWS Contrast?	N/A
N/A	Landing Slope (%)	N/A	N/A	DWS Length (in)	N/A
N/A	Landing X Slope (%)	N/A	N/A	DWS Full Width?	N/A
N/A	Landing Curb? (Y/N)	N/A	N/A	DWS Offset (in)	N/A
N/A	Shared Landing?	N/A			
N/A	Gutter Ponding?	N/A	N/A	Gutter Slope (%)	N/A
N/A	Gutter Lip Ht (in)	N/A	N/A	Gutter X Slope (%)	N/A
N/A	Painted X Walk1?	No	N/A	Painted X Walk2?	No
	X Walk 1 Direction	To W		X Walk 2 Direction	To S
N/A	X Walk 1 Width (in)	N/A	N/A	X Walk 2 Width (in)	N/A
	X Walk 1 Slope (%)	2.5		X Walk 2 Slope (%)	3.1
	X Walk 1 X Slope (%)	2.8		X Walk 2 X Slope (%)	1.4

N/A	Ramp inside XWalk1?	N/A	N/A	Ramp inside XWalk2?	N/A
	Road Slope (%)	1.1	N/A	Clear Space?	N/A
	Road X Slope (%)	2.1	N/A	Clear Space to XWalk (in)	N/A
N/A	Any Obstructions?	N/A	N/A	Storm Grate/Utility Hazard?	N/A
	Obstruction Type			Storm Grate/Utility Type	
		N/A			N/A
		Yes		Surface Condition? (G/P)	Good

Remove & Replace Curb Ramp With Two New Directional Ramps or Equivalent.

Total Cost: \$ 3200.00
