Access Compliance Report Public Rights-of-Way (Curb Ramps)

Intersection ID: 42530 Main Street: CASTLETOWN HOUSE DR Cross Street: RATHANGAN DR Location: SE ADA ID: 0460F7460D0E Ramp Type: PerpDiag Initial Pass/Fail: Fail **Overall Compliance: No Severity Score:** 8.75

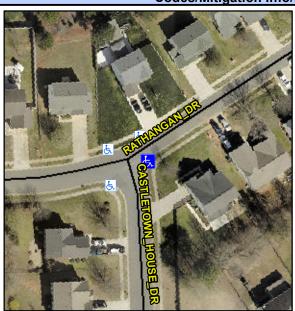
Not Found, R304.5.1

Comp	liance Description	Data	Comp	liance	Description	Data
N/A	Ramp Length (in)	48.0	Yes	Ramp	Slope (%)	7.4
No	Ramp Width (in)	40.0	Yes	Ramp	Ramp XSlope (%)	
N/A	Flare Type LT	N/A	N/A	Flare	Type RT	N/A
N/A	Flare Slope LT (%)	N/A	N/A	Flare	Slope RT (%)	N/A
N/A	Flare Traversable LT?	N/A	N/A	Flare	Traversable RT?	N/A
N/A	Landing Length (in)	N/A	N/A	DWS	Provided?	N/A
N/A	Landing Width (in)	N/A	N/A	DWS	Contrast?	N/A
N/A	Landing Slope (%)	N/A	N/A	DWS	Length (in)	N/A
N/A	Landing X Slope (%)	N/A	N/A	DWS	Full Width?	N/A
N/A	Landing Curb? (Y/N)	N/A	N/A	DWS	Offset (in)	N/A
N/A	Shared Landing?	N/A				
N/A	Gutter Ponding?	N/A	N/A	Gutte	r Slope (%)	N/A
N/A	Gutter Lip Ht (in)	N/A	N/A	Gutte	r X Slope (%)	N/A
N/A	Painted X Walk1?	No	N/A	Paint	ed X Walk2?	No
	X Walk 1 Direction	To NW		X Wa	lk 2 Direction	To SW
N/A	X Walk 1 Width (in)	N/A	N/A	X Wa	lk 2 Width (in)	N/A
	X Walk 1 Slope (%)	0.3		X Wa	lk 2 Slope (%)	2.5
	X Walk 1 X Slope (%)	1.9		X Wa	lk 2 X Slope (%)	0.2

N/A	Ramp inside XWalk1?	N/A	N/A	Ramp	inside XWalk2?	N/A
	Road Slope (%)	0.7	N/A	Clear	Space?	N/A
	Road X Slope (%)	2.2	N/A	Clear	Space to XWalk (in)	N/A
N/A	Any Obstructions?	N/A	N/A	Storm	Grate/Utility Hazard?	N/A
	Obstruction Type		l	Storm	n Grate/Utility Type	
		N/A				N/A

Stree Stop Stree Stop Possible Solutions: Remove & Replace Curb Ramp With Two New Directional Ramps or Equivalent.
