## Access Compliance Report Public Rights-of-Way (Curb Ramps)

Intersection ID: 10038349Main Street:SOUTH\_BVCross Street:N/ALocation:WADA ID: 04692F4C7CD3Ramp Type:PerpInitial Pass/Fail:FailOverall Compliance:NoSeverity Score:21.25

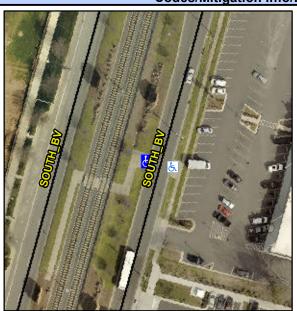
Field Measurements/Component Compliance								
		Data	Compliance Description		Data			
N/A	Ramp Length (in)	123.0	No	Ramp Slope (%)	10.4			
No	Ramp Width (in)	47.0	Yes	Ramp XSlope (%)	1.3			
N/A	Flare Type LT	N/A	N/A	Flare Type RT	N/A			
N/A	Flare Slope LT (%)	N/A	N/A	Flare Slope RT (%)	N/A			
N/A	Flare Traversable LT?	N/A	N/A	Flare Traversable RT?	N/A			
N/A	Landing Length (in)	N/A	N/A	DWS Provided?	N/A			
N/A	Landing Width (in)	N/A	N/A	DWS Contrast?	N/A			
N/A	Landing Slope (%)	N/A	N/A	DWS Length (in)	N/A			
N/A	Landing X Slope (%)	N/A	N/A	DWS Full Width?	N/A			
N/A	Landing Curb? (Y/N)	N/A	N/A	DWS Offset (in)	N/A			
N/A	Shared Landing?	N/A						
N/A	Gutter Ponding?	N/A	N/A	Gutter Slope (%)	N/A			
N/A	Gutter Lip Ht (in)	N/A	N/A	Gutter X Slope (%)	N/A			
N/A	Painted X Walk1?	No	N/A	Painted X Walk2?	N/A			
	X Walk 1 Direction	To E		X Walk 2 Direction	N/A			
N/A	X Walk 1 Width (in)	N/A	N/A	X Walk 2 Width (in)	N/A

X Walk 1 Slope (%)	4.9		X Walk 2 Slope (%)	N/A			
	X Walk 1 X Slope (%)	1.0		X Walk 2 X Slope (%)	N/A			
N/A	Ramp inside XWalk1?	N/A	N/A	Ramp inside XWalk2?	N/A			
	Road Slope (%)	N/A	N/A	Clear Space?	N/A			
	Road X Slope (%)	N/A	N/A	Clear Space to XWalk (in)	N/A			
N/A	Any Obstructions?	N/A	N/A	Storm Grate/Utility Hazard?	N/A			
	Obstruction Type			Storm Grate/Utility Type				
		N/A			N/A

Possible Solutions:	9
Remove & Replace Entire Ramp.	
•	N
	N
	N
	N
	N
Surveyor Notes:	N
N/A	N
	N
	N
	N
PROW/ADA:	N
Not Found, R304.5.1, R304.2.2	N
	N
	N
	N
	r
