Access Compliance Report Public Rights-of-Way (Curb Ramps)

Intersection ID: 52148 Main Street: OLD_ARDREY_KELL_RD Cross Street: ARDREY_PLACE_DR Location: SE

ADA ID: 04831BB636B3 Ramp Type: Combination1 Initial Pass/Fail: Fail Overall Compliance: No Severity Score: 22.5

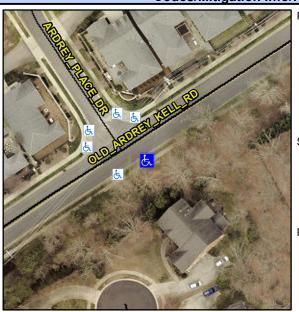
RT RP < 5%

Not Found, R304.5.1, R304.5.1, R304.2.2, R304.5.3, R304.3.2

Compl	iance Description	Data	Compl	iance Description	Data
N/A	Ramp Length LT (in)	49.0	N/A	Ramp Length RT (in)	44.0
Yes	Ramp Width LT (in)	48.0	No	Ramp Width RT (in)	47.0
No	Ramp Slope LT (%)	10.3	Yes	Ramp Slope RT (%)	0.1
No	Ramp XSlope LT (%)	2.9	No	Ramp XSlope RT (%)	3.4
N/A	Ramp Length (in)	47.0	No	Ramp Slope (%)	9.7
No	Ramp Width (in)	47.5	No	Ramp XSlope (%)	4.2
N/A	Flare Type LT	N/A	N/A	Flare Type RT	N/A
N/A	Flare Slope LT (%)	N/A	N/A	Flare Slope RT (%)	N/A
N/A	Flare Traversable LT?	N/A	N/A	Flare Traversable RT?	N/A
N/A	Landing Length (in)	N/A	N/A	DWS Provided?	N/A
N/A	Landing Width (in)	N/A	N/A	DWS Contrast?	N/A
N/A	Landing Slope (%)	N/A	N/A	DWS Length (in)	N/A
N/A	Landing X Slope (%)	N/A	N/A	DWS Full Width?	N/A
N/A	Landing Curb? (Y/N)	N/A	N/A	DWS Offset (in)	N/A
N/A	Shared Landing?	N/A			
N/A	Gutter Ponding?	N/A	N/A	Gutter Slope (%)	N/A
N/A	Gutter Lip Ht (in)	N/A	N/A	Gutter X Slope (%)	N/A
N/A	Painted X Walk1?	No	N/A	Painted X Walk2?	N/A

Remove & Replace Entire Ramp.
