# Access Compliance Report

## Public Rights-of-Way (Curb Ramps)

| Intersection ID: 28099 | Main Street: DELMAHOY_DR | Cross Street: ROYAL_PORTRUSH_DR | Location: SW |
| ADA ID: 0497751D582E | Ramp Type: Perp | Initial Pass/Fail: Fail | Overall Compliance: No |

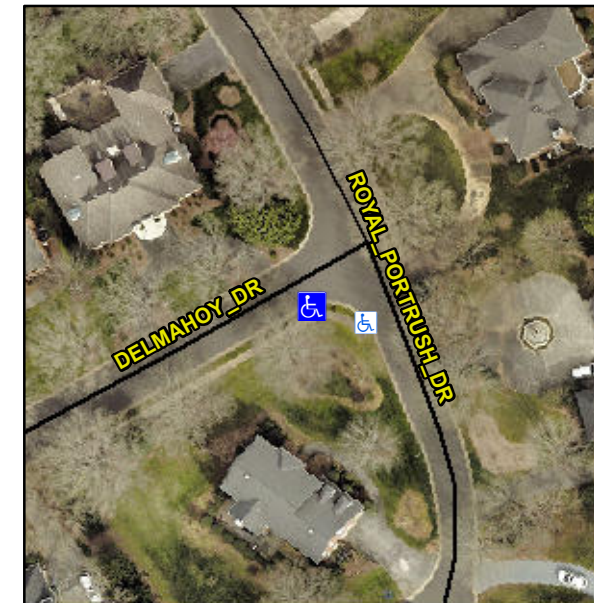
| | | Severity Score: 12.5 | |

**Not Found, R304.2.2**

| Compliance | Description | Data | Compliance | Description | Data |
|---|---|---|---|---|---|
| N/A | Ramp Length (in) | 94.0 | No | Ramp Slope (%) | 8.4 |

**Remove & Replace Entire Ramp.**

Total Cost: \$ 1850.00
