## Access Compliance Report Public Rights-of-Way (Curb Ramps)

Intersection ID: 21038 Main Street: BROCKTON\_LN Cross Street: PROVIDENCE\_RD Location: SW

ADA ID: 04A46A91F6F9 Ramp Type: BlendTrans2 Initial Pass/Fail: Fail Overall Compliance: No Severity Score: 8.75

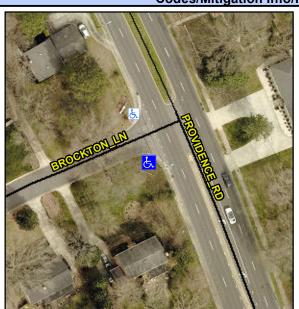
PROW/ADA:
Not Found, R304.5.1

Fleid Measurements/Component Compilance					
Compliance Description		Data	Compliance Description		Data
N/A	Ramp Length (in)	62.0	Yes	BlendTrans Slope (%)	3.6
No	Ramp Width (in)	47.0	Yes	BlendTrans XSlope (%)	1.9
N/A	Flare Type LT	N/A	N/A	Flare Type RT	N/A
N/A	Flare Slope LT (%)	N/A	N/A	Flare Slope RT (%)	N/A
N/A	Flare Traversable LT?	N/A	N/A	Flare Traversable RT?	N/A
N/A	Landing Length (in)	N/A	N/A	DWS Provided?	N/A
N/A	Landing Width (in)	N/A	N/A	DWS Contrast?	N/A
N/A	Landing Slope (%)	N/A	N/A	DWS Length (in)	N/A
N/A	Landing X Slope (%)	N/A	N/A	DWS Full Width?	N/A
N/A	Landing Curb? (Y/N)	N/A	N/A	DWS Offset (in)	N/A
N/A	Shared Landing?	N/A			
N/A	Gutter Ponding?	N/A	N/A	Gutter Slope (%)	N/A
N/A	Gutter Lip Ht (in)	N/A	N/A	Gutter X Slope (%)	N/A
N/A	Painted X Walk1?	No	N/A	Painted X Walk2?	No
	X Walk 1 Direction	To NE		X Walk 2 Direction	To NW
	X Walk 1 Width (in)	N/A		X Walk 2 Width (in)	N/A
	X Walk 1 Slope (%)	5.6		X Walk 2 Slope (%)	3.0

X Walk 1 X Slope (%)	2.9		X Walk 2 X Slope (%)	3.4
N/A	Ramp inside XWalk1?	N/A	N/A	Ramp inside XWalk2?	N/A
	Road Slope (%)	1.9		Clear Space?	N/A
	Road X Slope (%)	3.2	N/A	Clear Space to XWalk (in)	N/A
N/A	Any Obstructions?	N/A	N/A	Storm Grate/Utility Hazard?	N/A
	Obstruction Type		l	Storm Grate/Utility Type	
		N/A	l		N/A
			Yes	Surface Condition? (G/P)	Good

No

Curb Slope (%)

15.5

Remove & Replace Curb Ramp With
Two New Directional Ramps or
Equivalent.

Total Cost: \$ 3200.00
