Access Compliance Report

Public Rights-of-Way

Intersection ID: 32254	Main Street: BALLANTYNE_CROSSING_AV	Cross Street: BALLANTYNE_GLEN_WY	Location: SW
ADA ID: 04B01478C95D	Ramp Type: PerpDiag	Initial Pass/Fail: Fail	Overall Compliance: No
Severity Score: 12.5			
Codes/Mitigation Info/Possible Solution		Field Measurements/Component Compliance

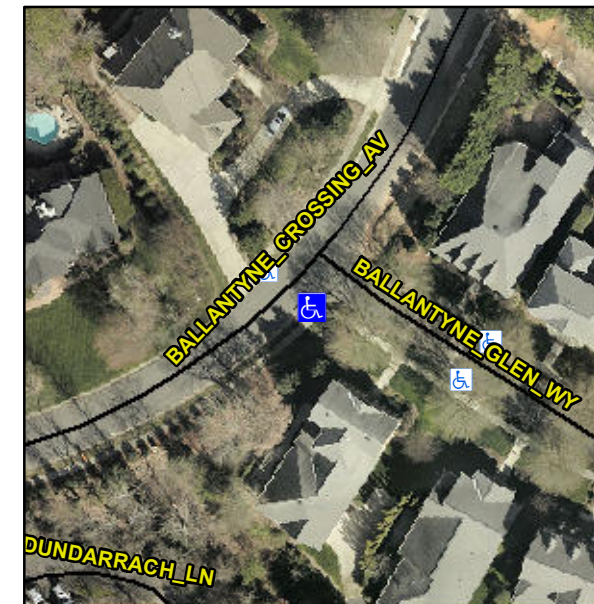
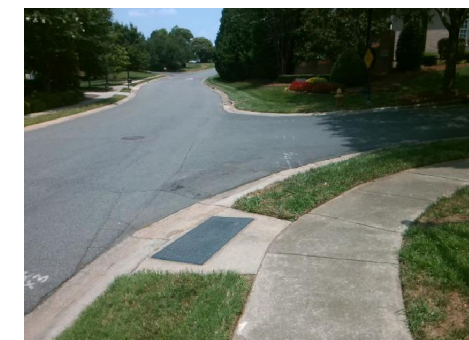
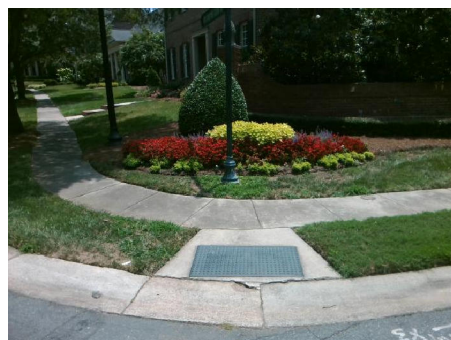
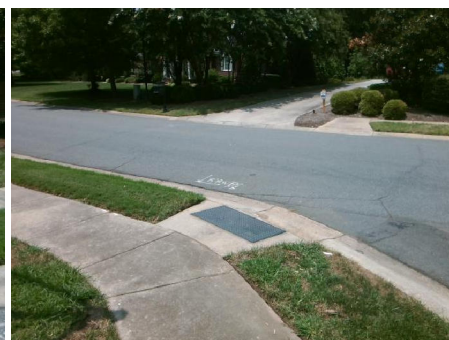
Not Found, R304.2.2

Compliance	Description	Data	Compliance	Description	Data
N/A	Ramp Length (in)	48.0	No	Ramp Slope (%)	8.6
Yes	Ramp Width (in)	48.0	Yes	Ramp XSlope (%)	0.6
N/A	Flare Type LT	N/A	N/A	Flare Type RT	N/A
N/A	Flare Slope LT (%)	N/A	N/A	Flare Slope RT (%)	N/A
N/A	Flare Traversable LT?	N/A	N/A	Flare Traversable RT?	N/A
N/A	Landing Length (in)	N/A	N/A	DWS Provided?	N/A
N/A	Landing Width (in)	N/A	N/A	DWS Contrast?	N/A
N/A	Landing Slope (%)	N/A	N/A	DWS Length (in)	N/A
N/A	Landing X Slope (%)	N/A	N/A	DWS Full Width?	N/A
N/A	Landing Curb? (Y/N)	N/A	N/A	DWS Offset (in)	N/A
N/A	Shared Landing?	N/A			
N/A	Gutter Ponding?	N/A	N/A	Gutter Slope (%)	N/A
N/A	Gutter Lip Ht (in)	N/A	N/A	Gutter X Slope (%)	N/A
N/A	Painted X Walk1?	No	N/A	Painted X Walk2?	No
	X Walk 1 Direction	To NE		X Walk 2 Direction	To NW
N/A	X Walk 1 Width (in)	N/A	N/A	X Walk 2 Width (in)	N/A
	X Walk 1 Slope (%)	3.3		X Walk 2 Slope (%)	4.6
	X Walk 1 X Slope (%)	3.0		X Walk 2 X Slope (%)	2.5

N/A	Ramp inside XWalk1?	N/A	N/A	Ramp inside XWalk2?	N/A
	Road Slope (%)	0.9	N/A	Clear Space?	N/A
	Road X Slope (%)	5.4	N/A	Clear Space to XWalk (in)	N/A
N/A	Any Obstructions?	N/A	N/A	Storm Grate/Utility Hazard?	N/A
	Obstruction Type			Storm Grate/Utility Type	
		N/A			N/A
		Yes		Surface Condition? (G/P)	Good

Remove & Replace Curb Ramp With Two New Directional Ramps or Equivalent.
