# Access Compliance Report

## Public Rights-of-Way

### (Curb Ramps)

Intersection ID: N/A	Main Street: CRESSWIND BV	Cross Street: SHOFF CIR	Location: NW
ADA ID: 04CEC6C9EE2E	Ramp Type: Perp	Initial Pass/Fail: Pass	Overall Compliance: No
			Severity Score: 15.25

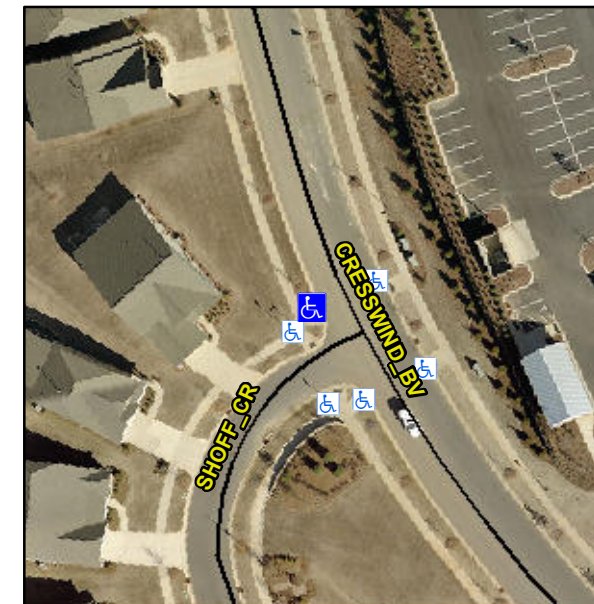
Compliance	Description	Data	Compliance	Description	Data
N/A	Ramp Length (in)	107.0	Yes	Ramp Slope (%)	6.1
Yes	Ramp Width (in)	48.0	Yes	Ramp XSlope (%)	2.7
N/A	Flare Type LT	Sloped	N/A	Flare Type RT	N/A
N/A	Flare Slope LT (%)	9.1	N/A	Flare Slope RT (%)	6.9
N/A	Flare Traversable LT?	No	N/A	Flare Traversable RT?	No
Yes	Landing Length (in)	60.0	Yes	DWS Provided?	Yes
Yes	Landing Width (in)	60.0	Yes	DWS Contrast?	Yes
Yes	Landing Slope (%)	1.8	Yes	DWS Length (in)	24.5
Yes	Landing X Slope (%)	3.1	Yes	DWS Full Width?	Yes
N/A	Landing Curb? (Y/N)	No	No	DWS Offset (in)	6.5
N/A	Shared Landing?	No			
Yes	Gutter Ponding?	No	Yes	Gutter Slope (%)	4.7
No	Gutter Lip Ht (in)	1.0	Yes	Gutter X Slope (%)	2.7
N/A	Painted X Walk1?	No	N/A	Painted X Walk2?	N/A
	X Walk 1 Direction	To NE		X Walk 2 Direction	N/A
N/A	X Walk 1 Width (in)	N/A	N/A	X Walk 2 Width (in)	N/A
	X Walk 1 Slope (%)	4.2		X Walk 2 Slope (%)	N/A
	X Walk 1 X Slope (%)	5.4		X Walk 2 X Slope (%)	N/A

N/A	Ramp inside XWalk1?	N/A	N/A	Ramp inside XWalk2?	N/A
	Road Slope (%)	N/A	N/A	Clear Space?	Yes
	Road X Slope (%)	N/A	N/A	Clear Space to XWalk (in)	N/A
Yes	Any Obstructions?	No	Yes	Storm Grate/Utility Hazard?	No
	Obstruction Type			Storm Grate/Utility Type	
			N/A		N/A
			Yes	Surface Condition? (G/P)	Good

Possible Solutions:

**Remove & Replace Detectable Warning System. Grind Gutter Lip.**

**R305.2, R302.7.2**
