# Access Compliance Report

## Public Rights-of-Way

### (Curb Ramps)

Intersection ID: 10142	Main Street: TUCKASEEGEE_RD	Cross Street: TODDVILLE_RD	Location:	N
ADA ID: 04D469E963AF	Ramp Type: Perp	Initial Pass/Fail: Fail	Overall Compliance: No	Severity Score: 10

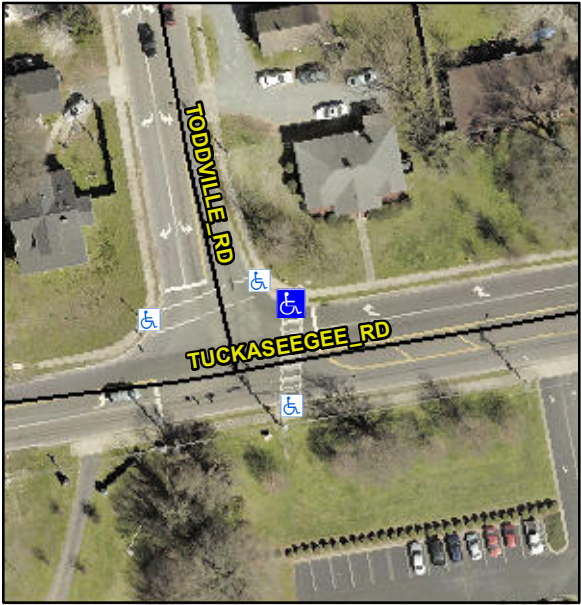
Possible Solutions:		<b>Compliance</b>	<b>Description</b>	<b>Data</b>
	<b>Remove &amp; Replace Entire Ramp.</b>		<b>Yes</b>	Ramp Length (in)	84.0
			<b>No</b>	Ramp Width (in)	41.0
			<b>N/A</b>	Flare Type LT	N/A
			<b>N/A</b>	Flare Slope LT (%)	N/A
			<b>N/A</b>	Flare Traversable LT?	N/A
			<b>N/A</b>	Landing Length (in)	N/A
			<b>N/A</b>	Landing Width (in)	N/A
			<b>N/A</b>	Landing Slope (%)	N/A
			<b>N/A</b>	Landing X Slope (%)	N/A
<p>Surveyor Notes:</p> <p><b>N/A</b></p> <p>PROW/ADA:</p> <p><b>Not Found, R304.5.1, R304.5.3</b></p>			<b>N/A</b>	Flare Type RT	N/A
			<b>N/A</b>	Flare Slope RT (%)	N/A
			<b>N/A</b>	Flare Traversable RT?	N/A
			<b>N/A</b>	DWS Provided?	N/A
			<b>N/A</b>	DWS Contrast?	N/A
			<b>N/A</b>	DWS Length (in)	N/A
			<b>N/A</b>	DWS Full Width?	N/A
			<b>N/A</b>	DWS Offset (in)	N/A
			<b>N/A</b>	Shared Landing?	N/A

<b>N/A</b>	Gutter Ponding?	N/A
			<b>N/A</b>	Gutter Lip Ht (in)	N/A
			<b>N/A</b>	Painted X Walk1?	Yes
				X Walk 1 Direction	To S
			<b>N/A</b>	X Walk 1 Width (in)	110.0
				X Walk 1 Slope (%)	0.7
				X Walk 1 X Slope (%)	2.4
			<b>N/A</b>	Ramp inside XWalk1?	Yes
			<b>N/A</b>	Road Slope (%)	N/A
			<b>N/A</b>	Road X Slope (%)	N/A
			<b>N/A</b>	Any Obstructions?	N/A
				Obstruction Type	
			<b>N/A</b>		
			<b>N/A</b>		
			<b>N/A</b>		
			<b>N/A</b>		
			<b>N/A</b>		
			<b>N/A</b>		
			<b>N/A</b>		
			<b>N/A</b>		
			<b>N/A</b>		
Total Cost:		\$ 1850.00			
			<b>N/A</b>		
			<b>Yes</b>	Surface Condition? (G/P)	Good
