# Access Compliance Report

## Public Rights-of-Way

### (Curb Ramps)

Intersection ID: 44317	Main Street: E_9TH_ST	Cross Street: N_CALDWELL_ST	Location: E
ADA ID: 04D65C117262	Ramp Type: Perp	Initial Pass/Fail: Fail	Overall Compliance: No
Severity Score: 8.75			
Codes/Mitigation Info/Possible Solution		Field Measurements/Component Compliance

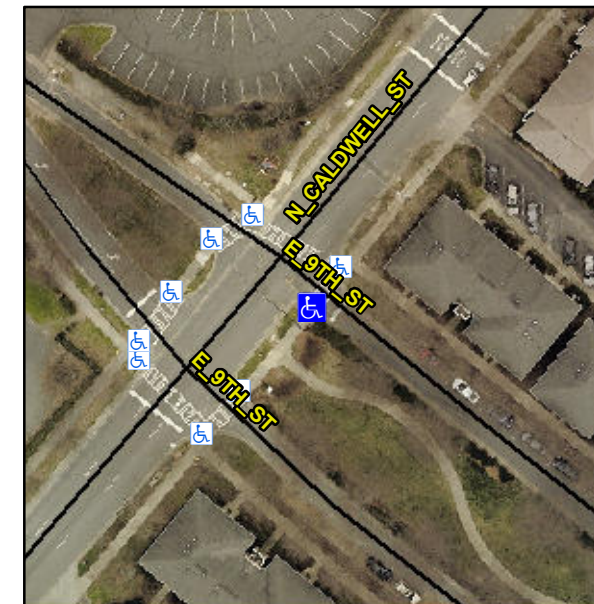
**Not Found, R304.5.1**

Compliance	Description	Data	Compliance	Description	Data
N/A	Ramp Length (in)	72.0	Yes	Ramp Slope (%)	6.5
No	Ramp Width (in)	47.0	Yes	Ramp XSlope (%)	1.8
N/A	Flare Type LT	N/A	N/A	Flare Type RT	N/A
N/A	Flare Slope LT (%)	N/A	N/A	Flare Slope RT (%)	N/A
N/A	Flare Traversable LT?	N/A	N/A	Flare Traversable RT?	N/A
N/A	Landing Length (in)	N/A	N/A	DWS Provided?	N/A
N/A	Landing Width (in)	N/A	N/A	DWS Contrast?	N/A
N/A	Landing Slope (%)	N/A	N/A	DWS Length (in)	N/A
N/A	Landing X Slope (%)	N/A	N/A	DWS Full Width?	N/A
N/A	Landing Curb? (Y/N)	N/A	N/A	DWS Offset (in)	N/A
N/A	Shared Landing?	N/A			
N/A	Gutter Ponding?	N/A	N/A	Gutter Slope (%)	N/A
N/A	Gutter Lip Ht (in)	N/A	N/A	Gutter X Slope (%)	N/A
N/A	Painted X Walk1?	Yes	N/A	Painted X Walk2?	N/A
	X Walk 1 Direction	To NE		X Walk 2 Direction	N/A
N/A	X Walk 1 Width (in)	108.5	N/A	X Walk 2 Width (in)	N/A
	X Walk 1 Slope (%)	0.4		X Walk 2 Slope (%)	N/A
	X Walk 1 X Slope (%)	3.2		X Walk 2 X Slope (%)	N/A

N/A	Ramp inside XWalk1?	Yes	N/A	Ramp inside XWalk2?	N/A
	Road Slope (%)	N/A	N/A	Clear Space?	N/A
	Road X Slope (%)	N/A	N/A	Clear Space to XWalk (in)	N/A
N/A	Any Obstructions?	N/A	N/A	Storm Grate/Utility Hazard?	N/A
	Obstruction Type			Storm Grate/Utility Type	
		N/A			N/A
		Yes		Surface Condition? (G/P)	Good

**Remove & Replace Entire Ramp.**
